# Satellite-Based Damage Assessment for City of Sittwe, Sittwe Township

Assessment based on satellite imagery recorded on morning of 31 October 2012

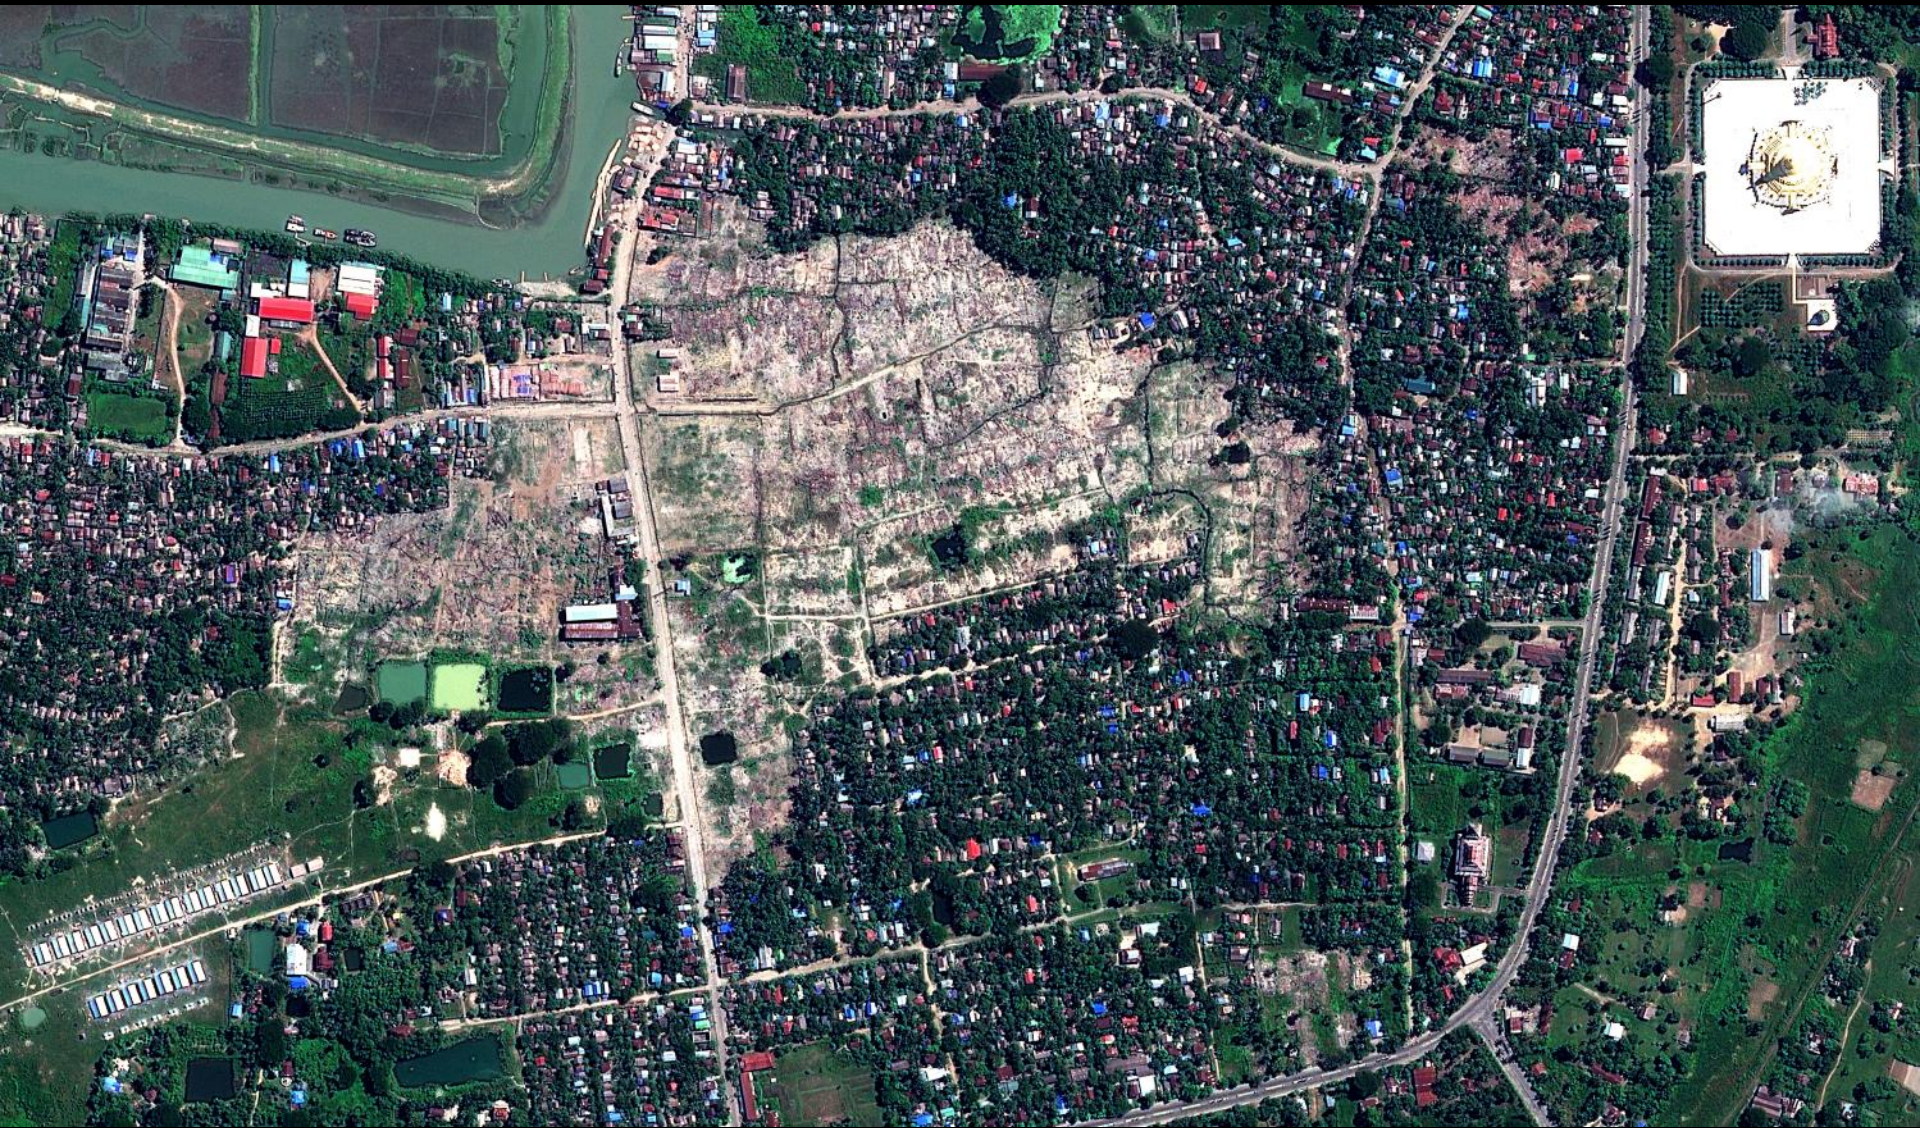
# Sittwe (Destruction Zone 1) on 31 October 2012

Post-attack view of largest concentration of building destruction

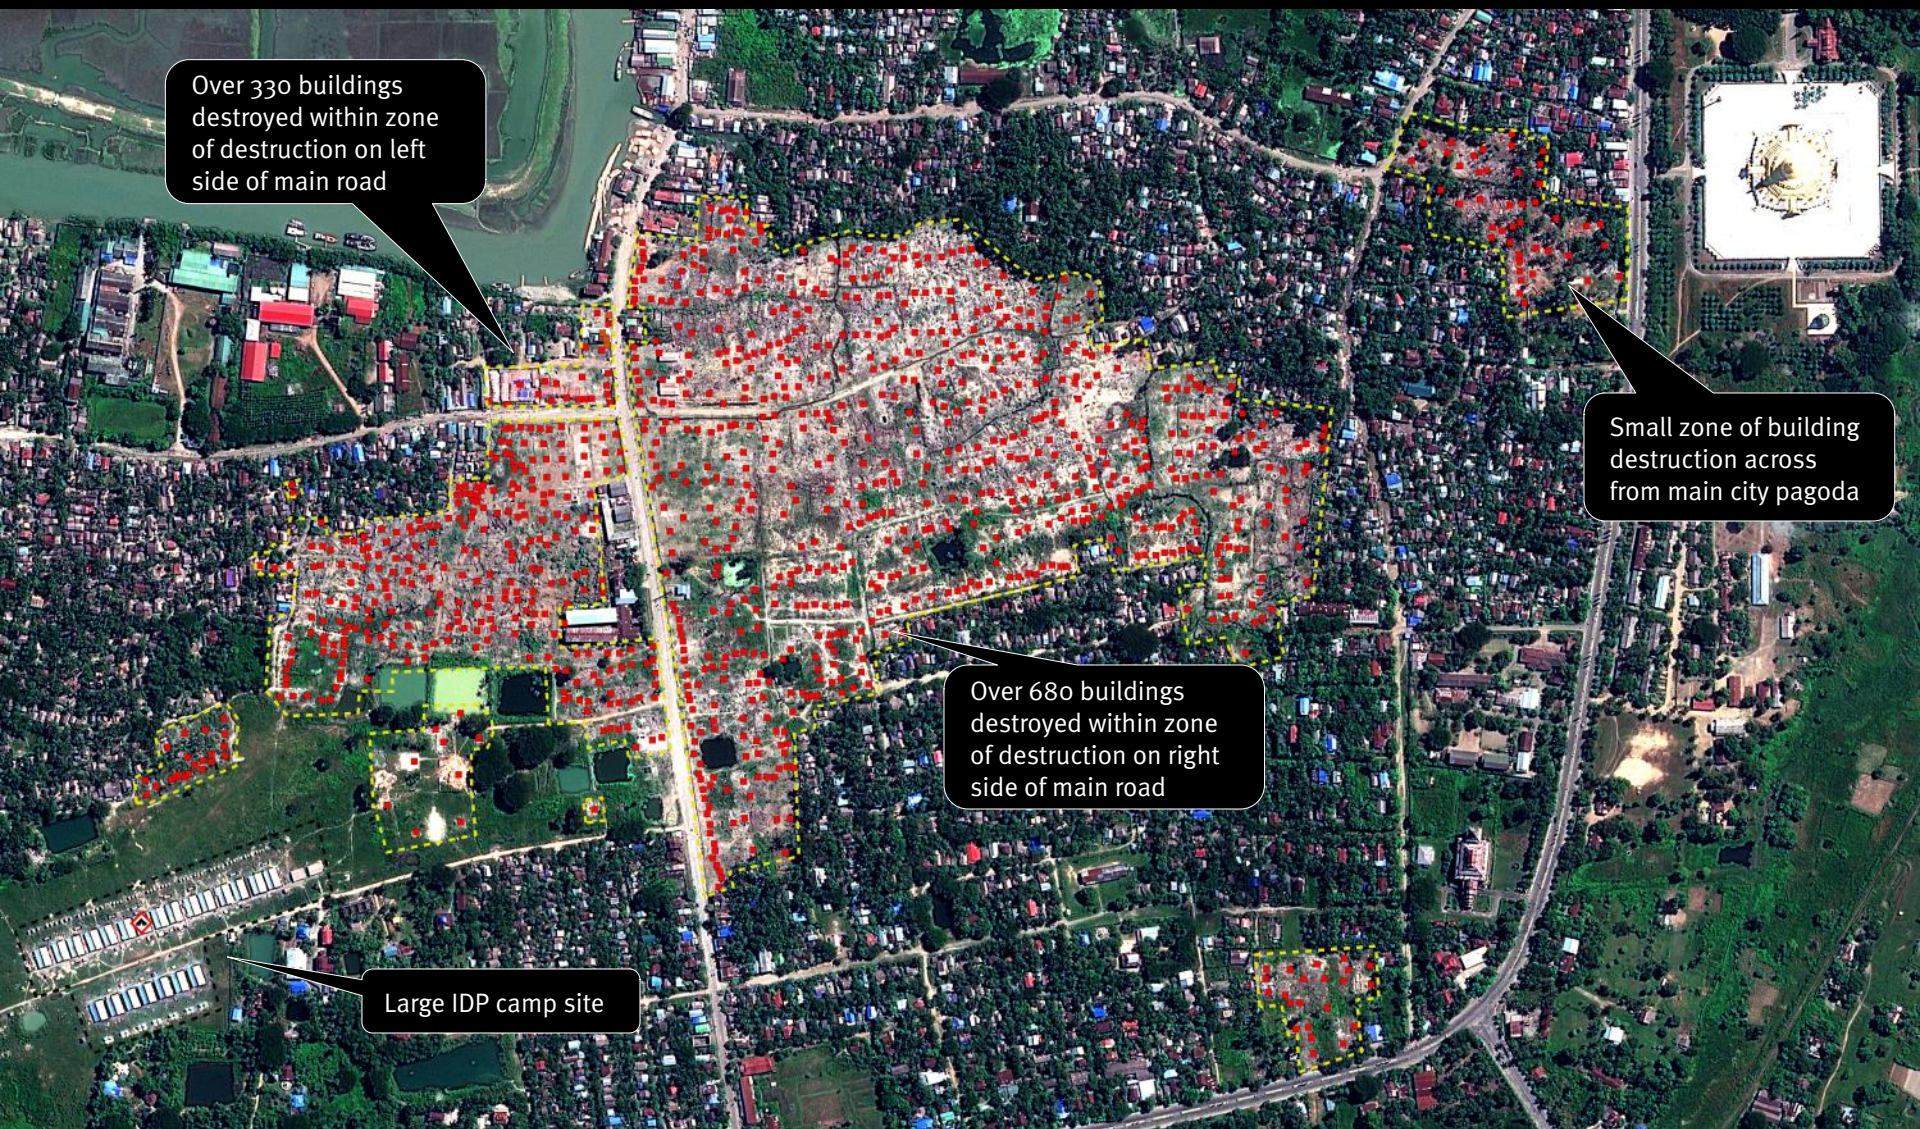
# Sittwe (Destruction Zone 1) on 31 October 2012

Post-attack view of largest concentration of building destruction—Damage sites annotated

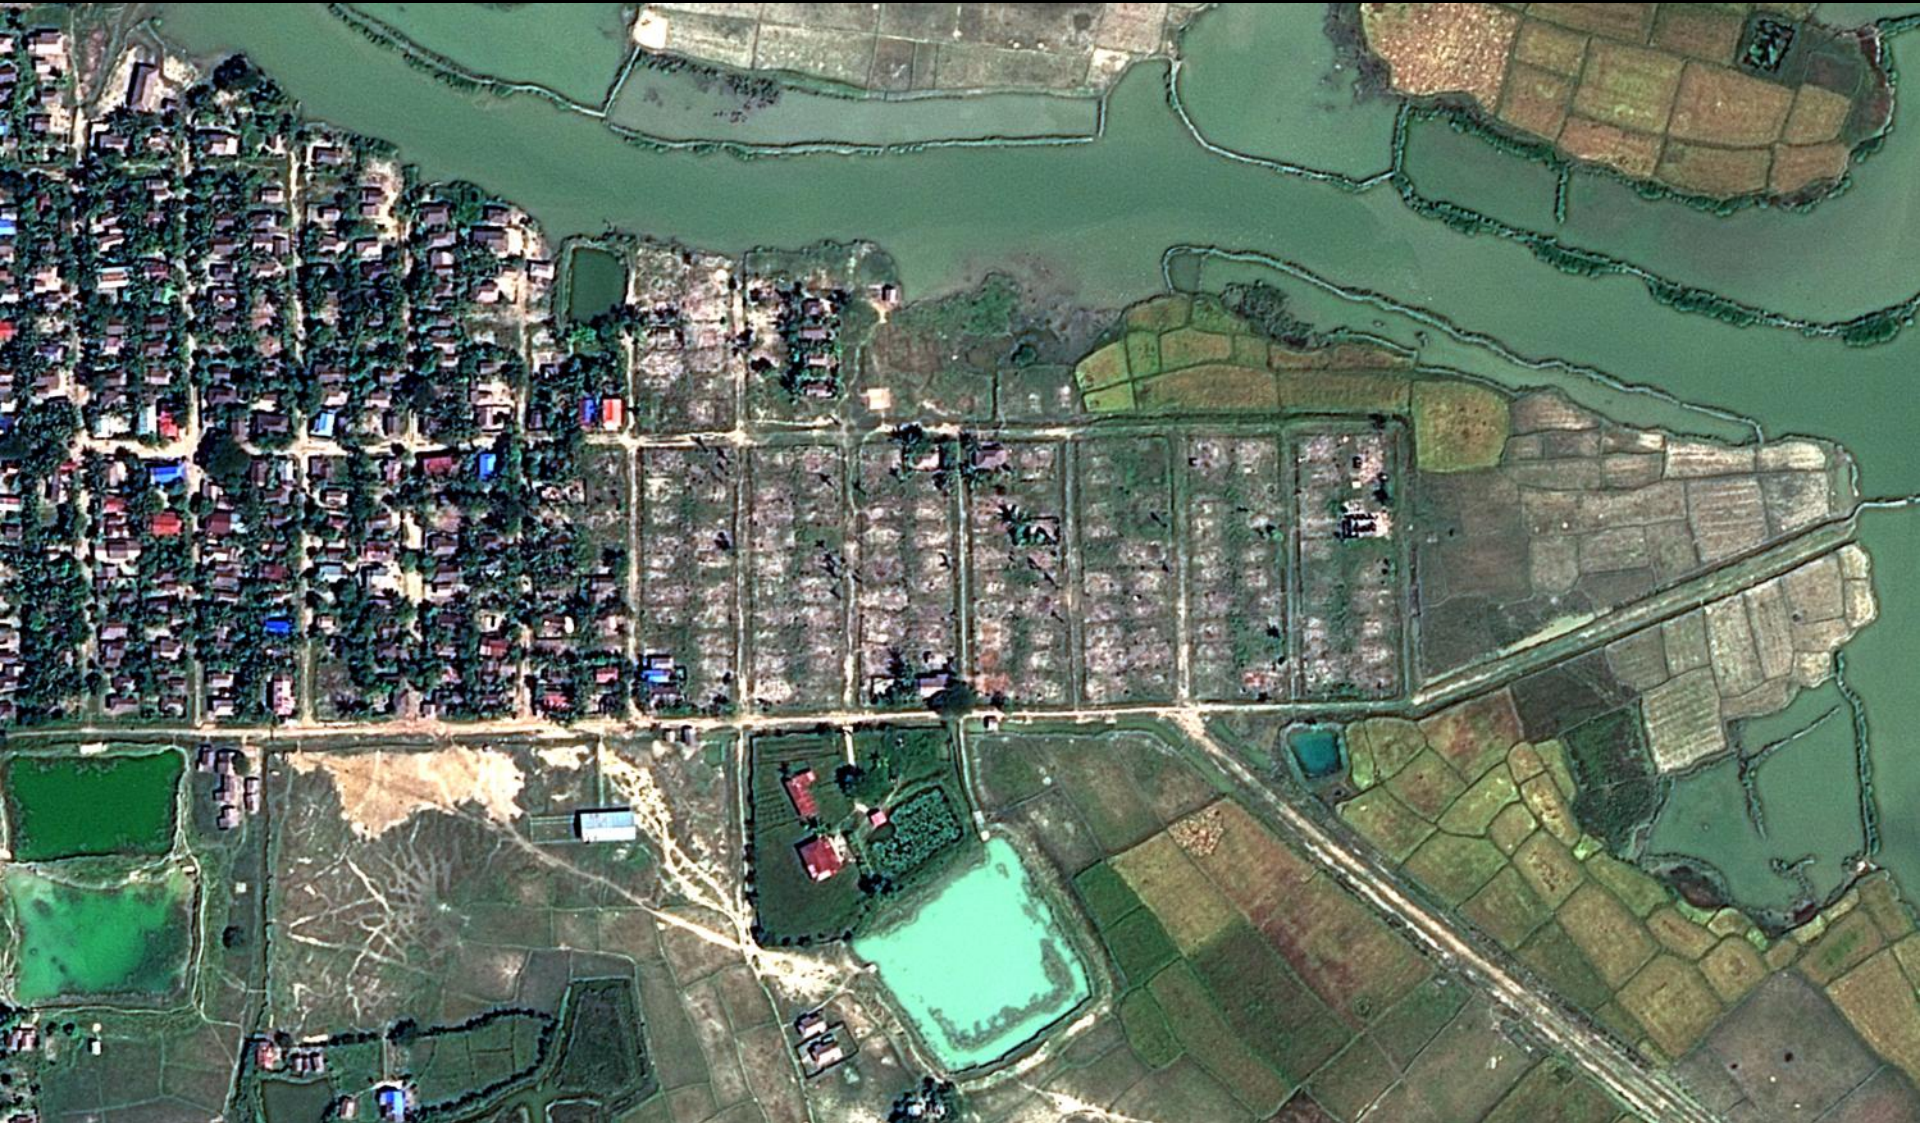
# Sittwe (Destruction Zone 2) on 31 October 2012

Post-attack view of northern-most concentration of building destruction

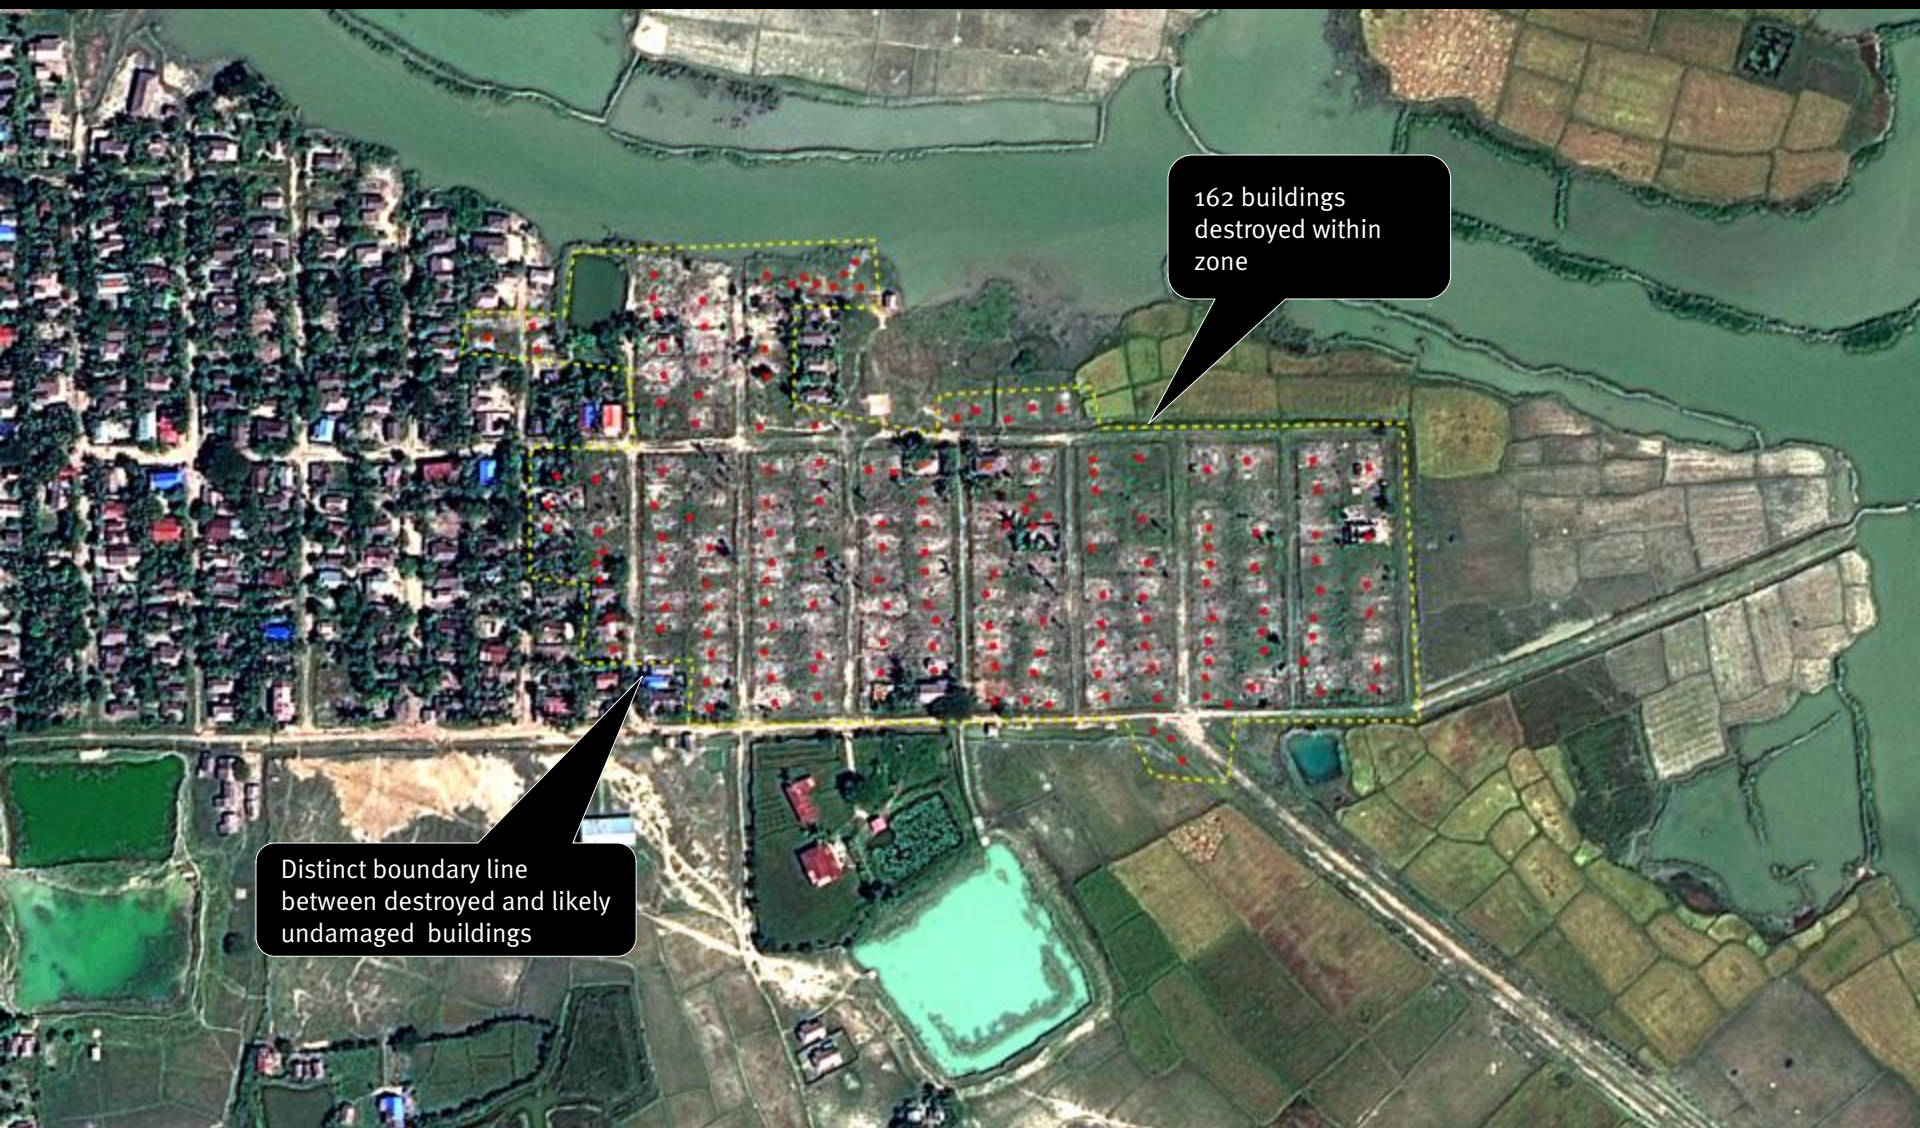
# Sittwe (Destruction Zone 2) on 31 October 2012:

Post-attack view of northern-most concentration of building destruction—Damage sites annotated

Distinct boundary line  
between destroyed and likely  
undamaged buildings

162 buildings  
destroyed within  
zone

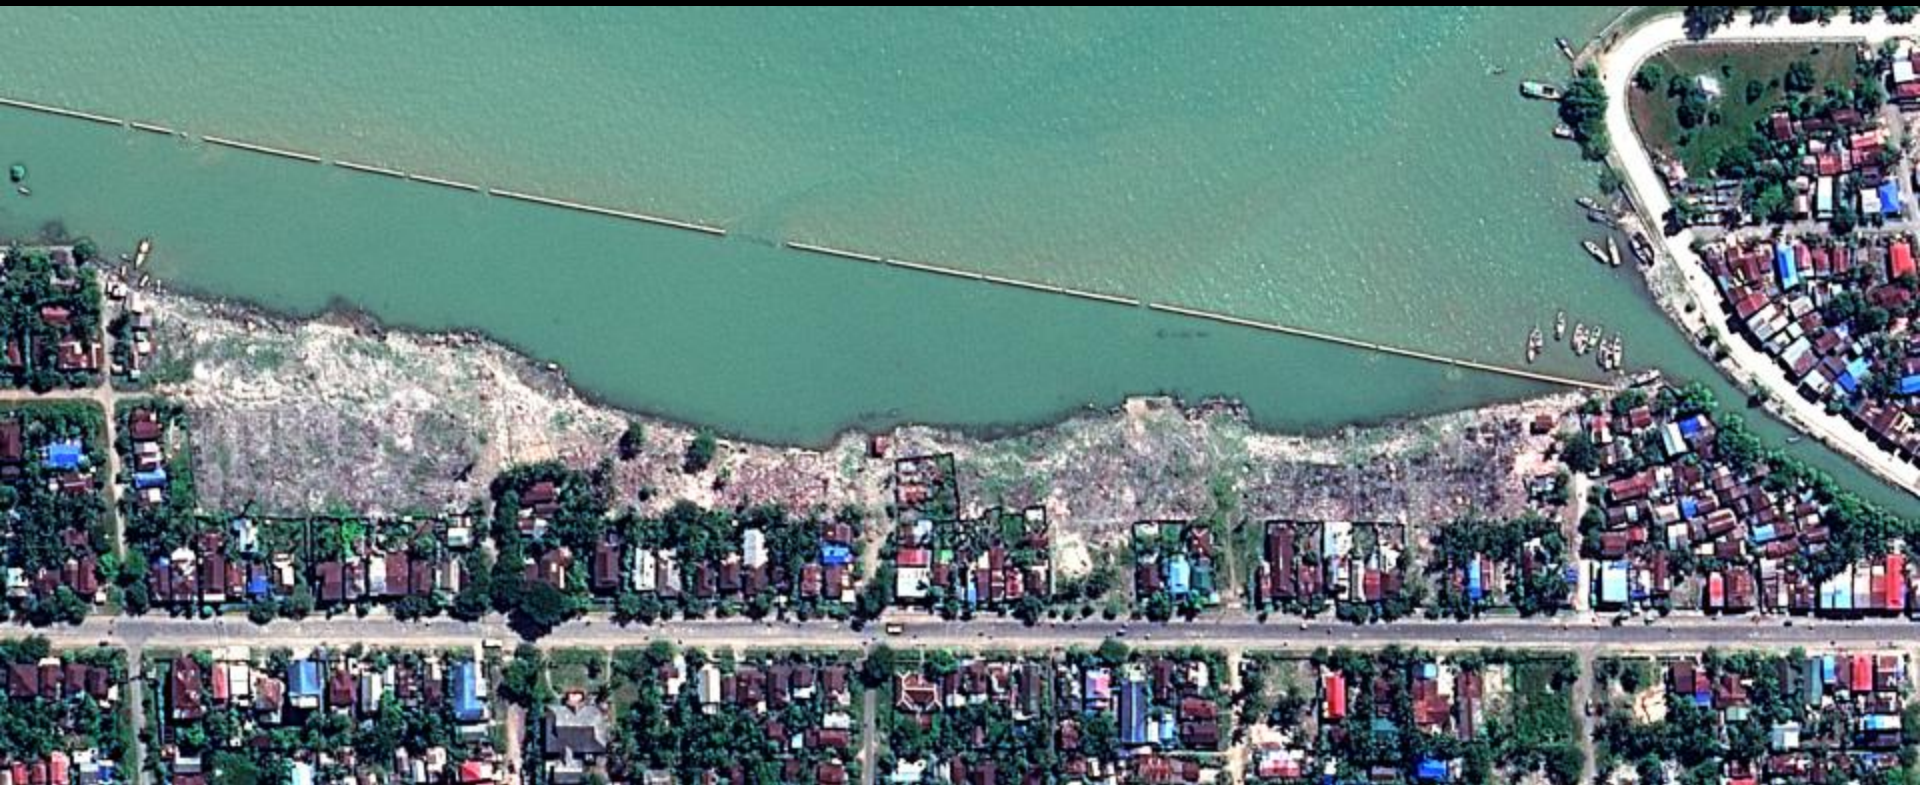
# Sittwe (Destruction Zone 3) on 31 October 2012

Post-attack view of concentration of building destruction along water front

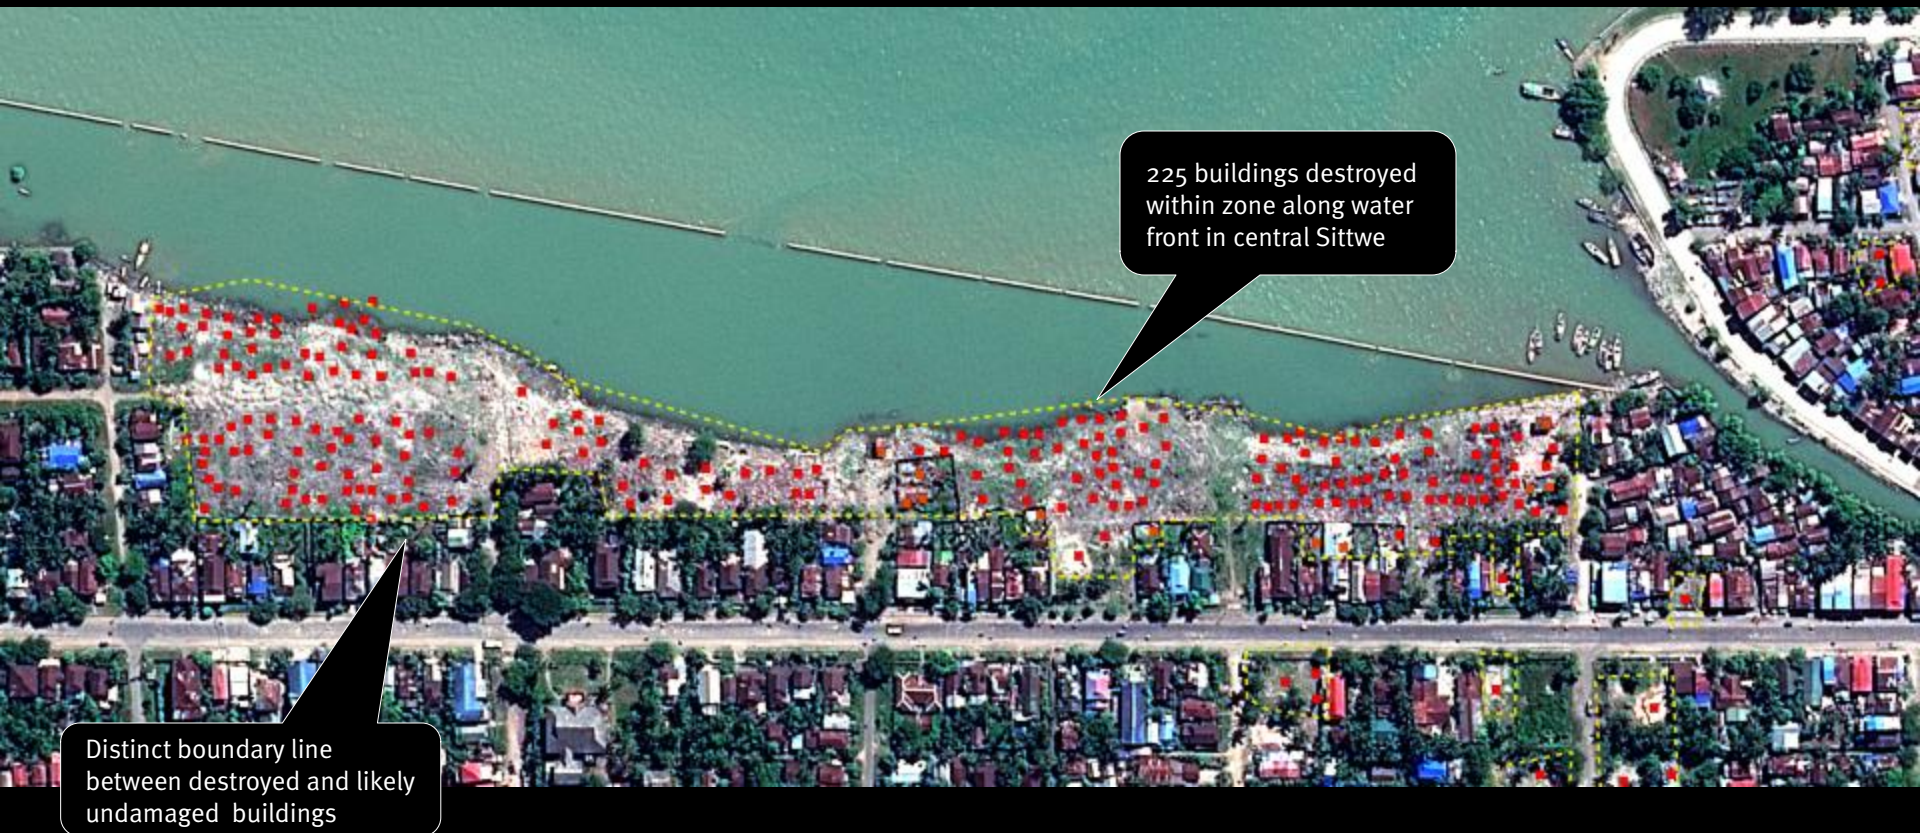
# Sittwe (Destruction Zone 3) on 31 October 2012

Post-attack view of concentration of building destruction along water front
