Discussion of Observed Building Damages in Tamarasheni (26 August 2008)

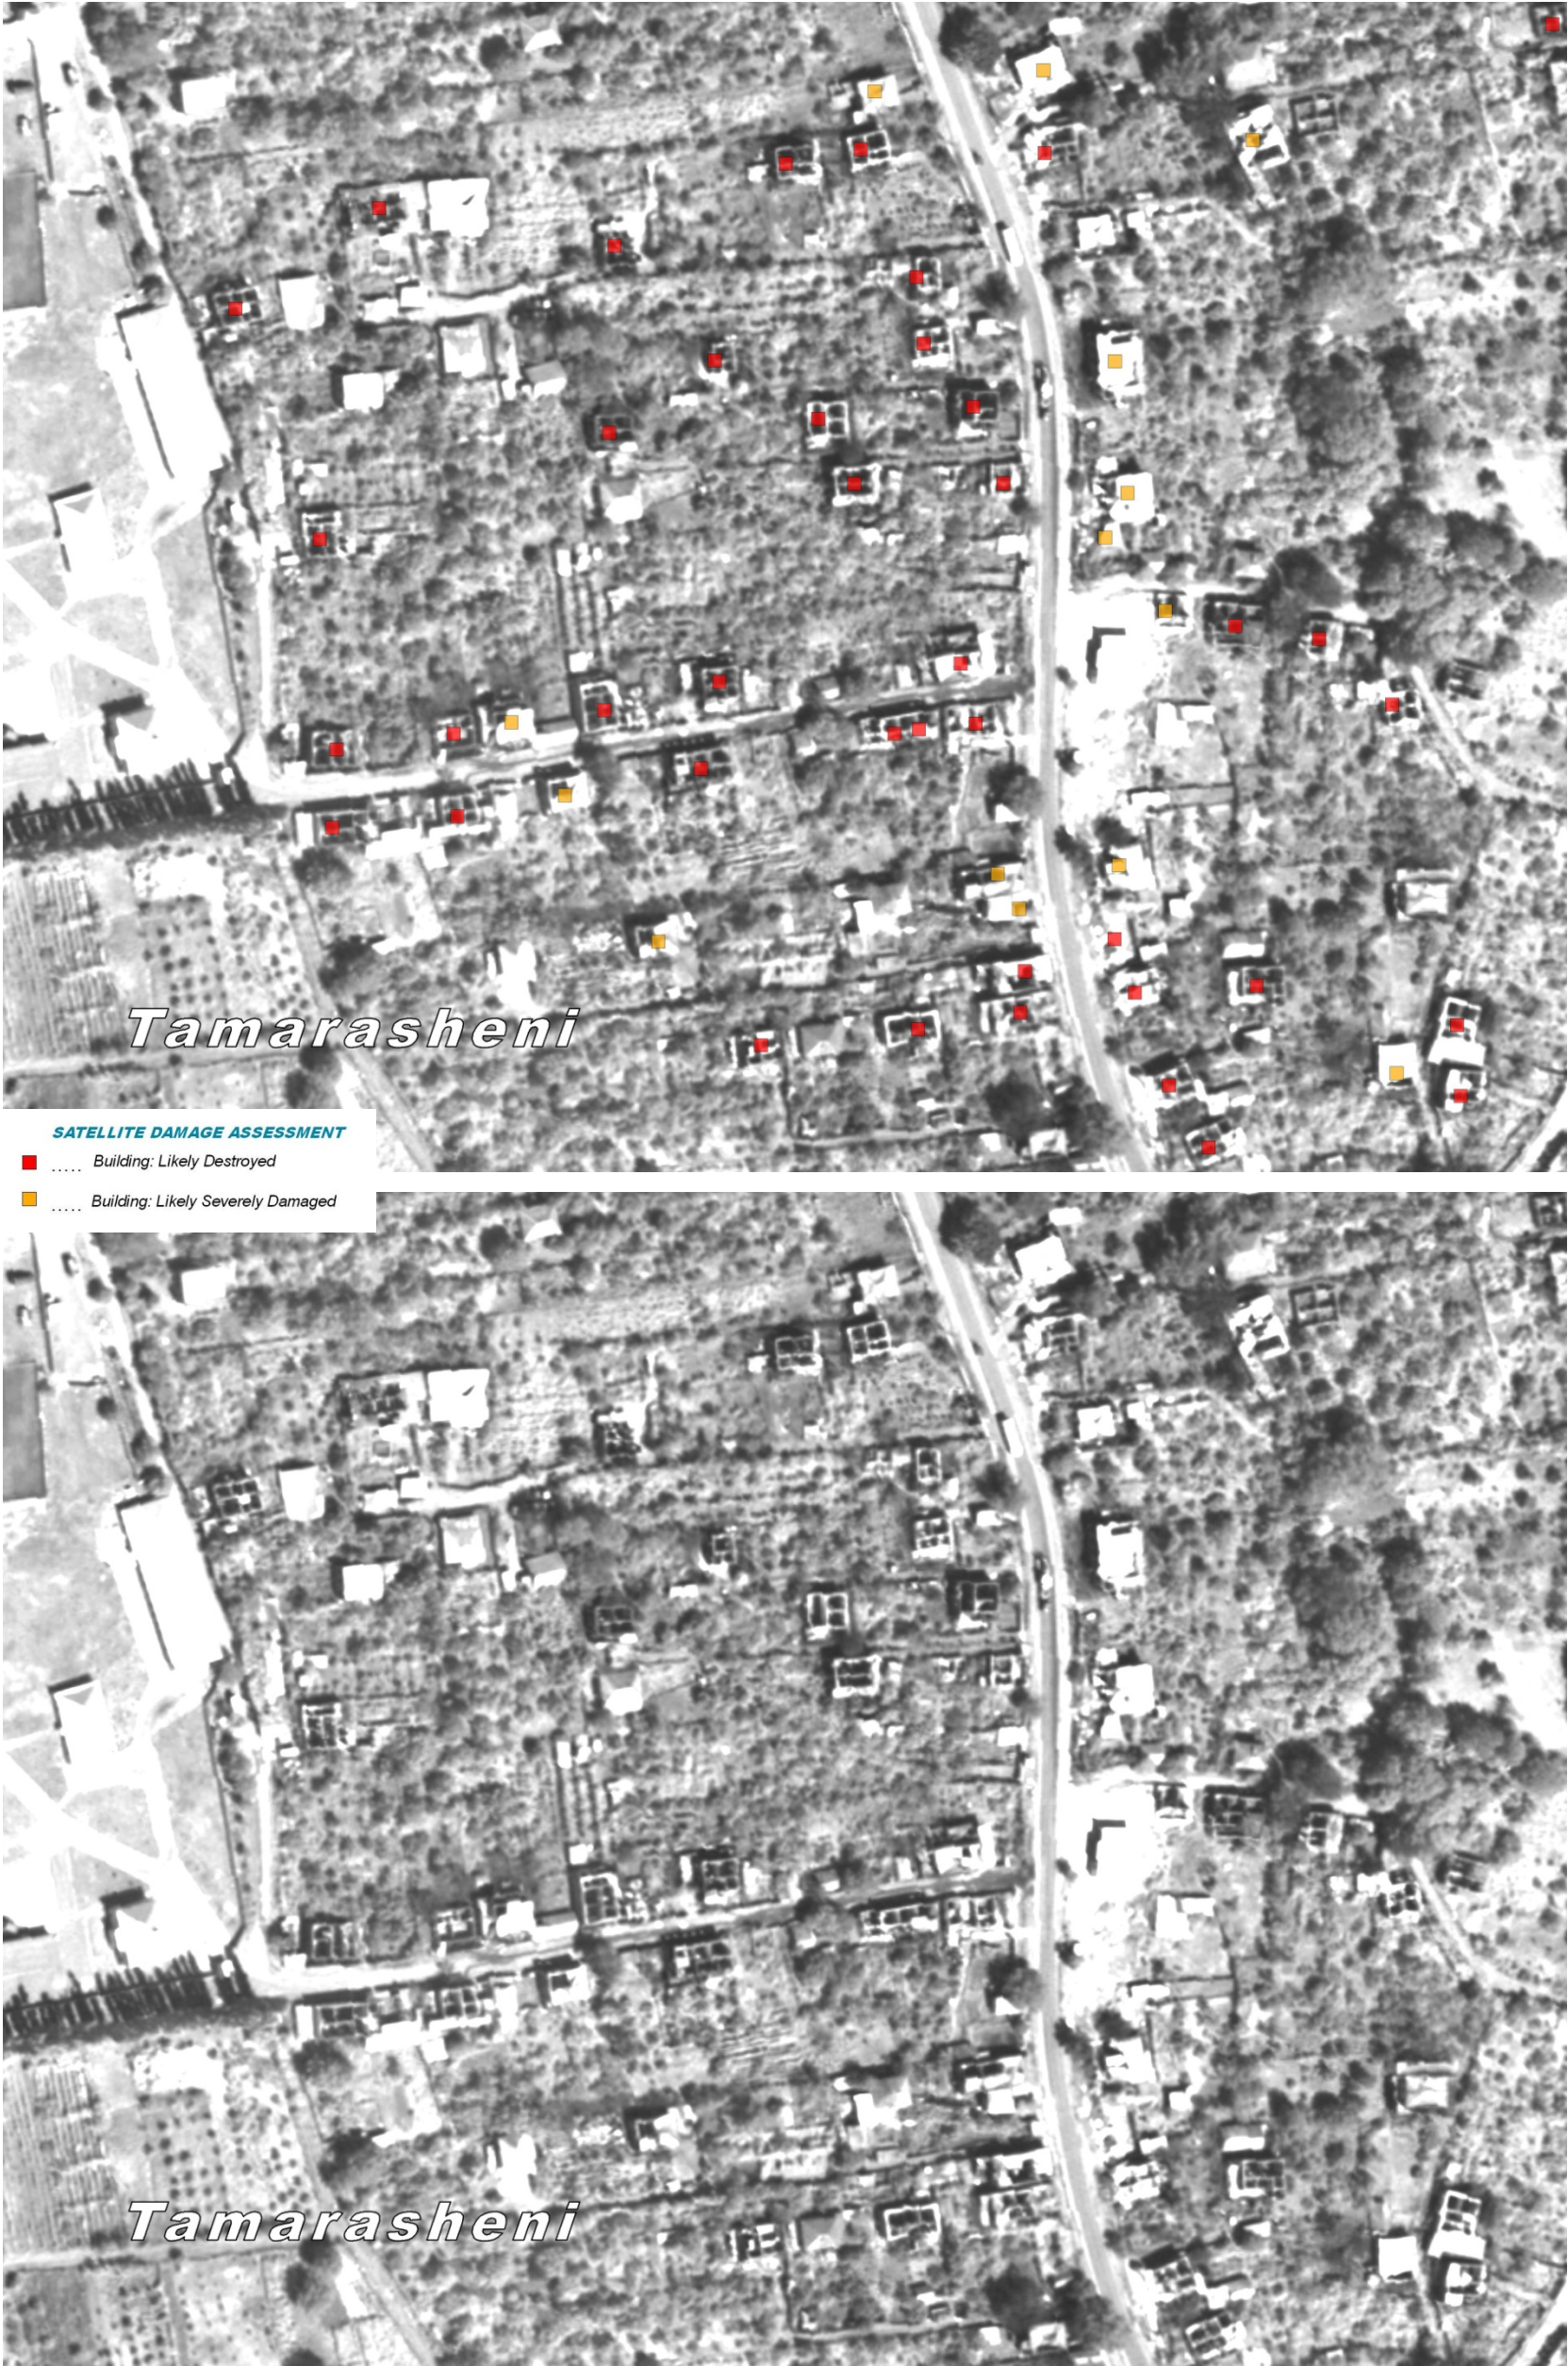
The typical building damages identified in the satellite image below (Worldview1 - 50cm) from 19 August 2008 are generally consistent with building fires which leave the interior and exterior masonry walls intact but destroy the wood-frame roof. There are no observed impact craters in this area which would be expected from mortars or missile explosions. Of the identified damaged buildings, there are a minority with collapsed exterior walls located along the main north-south road (P2), which is a common damage signature from ground artillery. It should be noted that these damages are similar to those observed in central Tskhinvali, where both suspected fire and possible artillery damage signatures exist.

(The first image contains the damage assessment points-the bottom image without the points)
