Satellite-Based Damage Assessment of Affected Villages in Maungdaw District

(Assessment based on satellite imagery recorded on the mornings of 22 October, 3 and 10 November 2016)

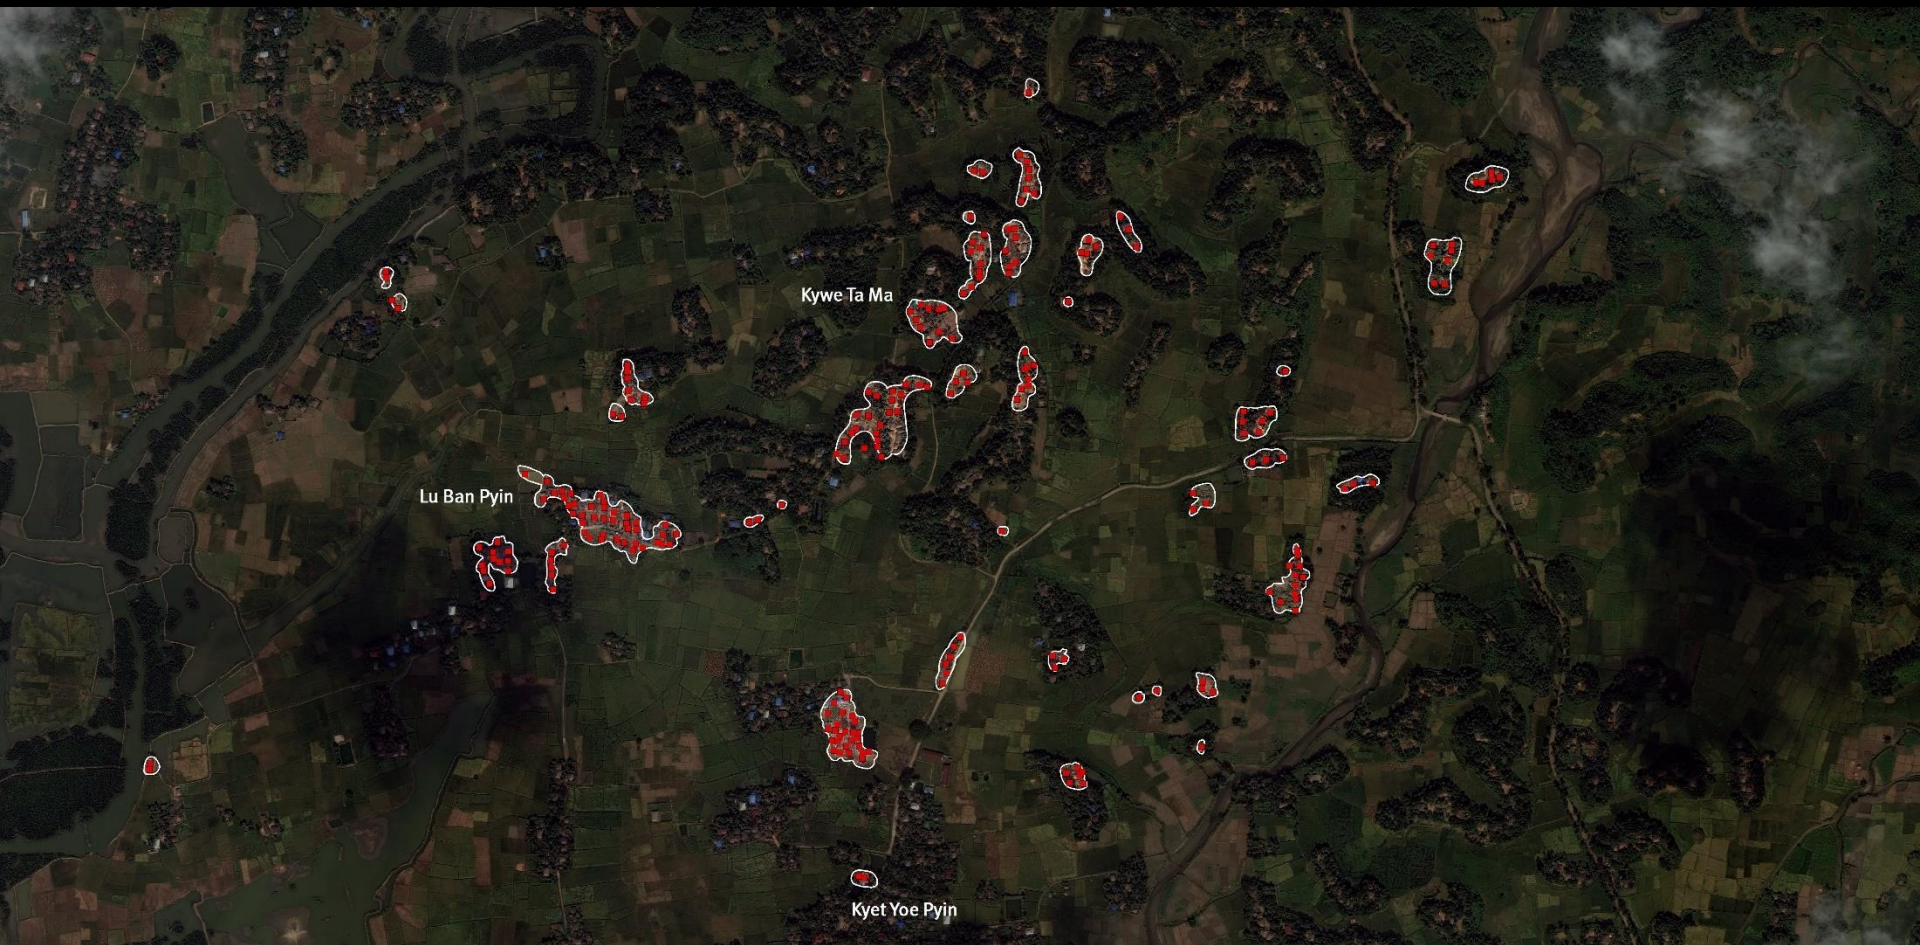
Overview of Building destruction in the village of Kyet Yoe Pyin, Maungdaw District

A total of 245 buildings were destroyed in the village of Kyet Yoe Pyin (and the sub-villages of Lu Ban Pyin and Kywe Ta Ma) based on satellite imagery recorded on the mornings of 22 October and 10 November 2016. Active fires were detected in multiple locations in the village on 14 October by an environmental satellite sensor. The presence of extensive burn scars and active fires are consistent with arson.

Because of dense tree cover it is possible that a limited number of fire-affected buildings were not detected. The actual number of building destruction in Kyet Yoe Pyin could be higher.

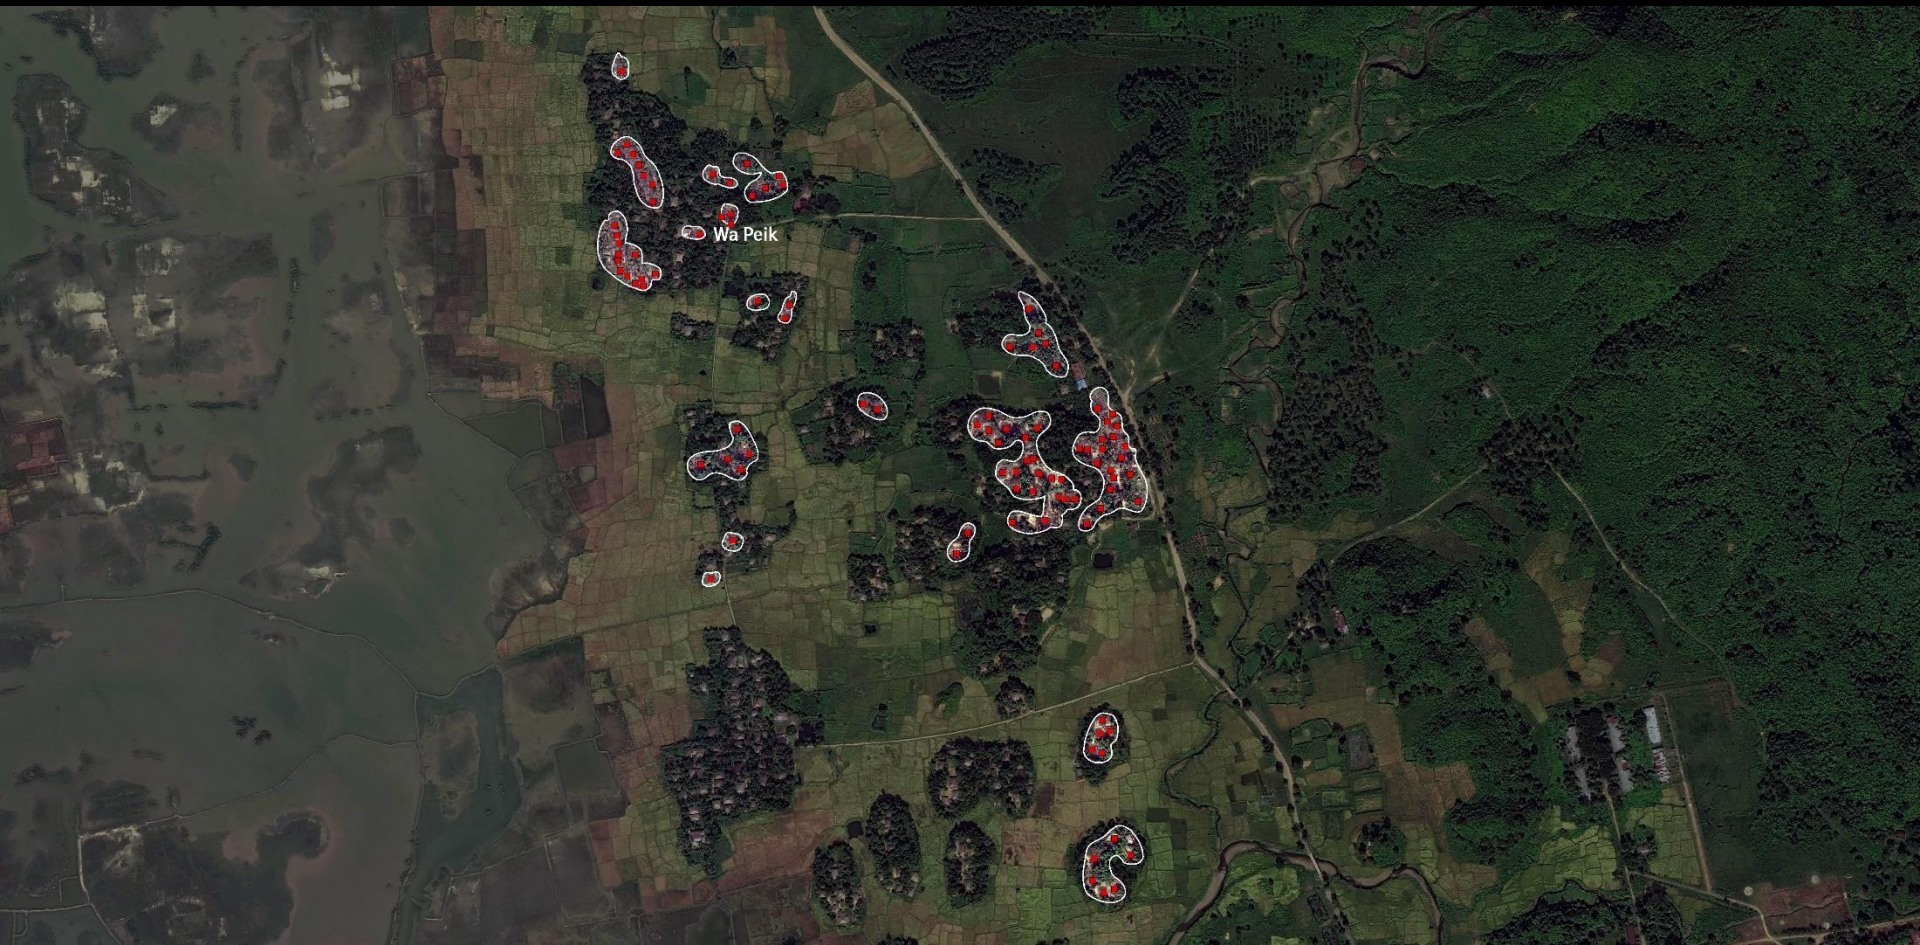
Overview of Building destruction in the village of Wa Peik (Kyee Kan Pyin), Maungdaw District

A total of 100 buildings were destroyed in the village of Wa Peik (Kyee Kan Pyin) based on satellite imagery recorded on the mornings of 22 October, 3 and 10 November 2016. Active fires were detected in multiple locations in the village on 09 October by an environmental satellite sensor. The presence of extensive burn scars and active fires are consistent with arson.

Because of dense tree cover it is possible that a limited number of fire-affected buildings were not detected. The actual number of building destruction in Wa Peik (Kyee Kan Pyin) could be higher.

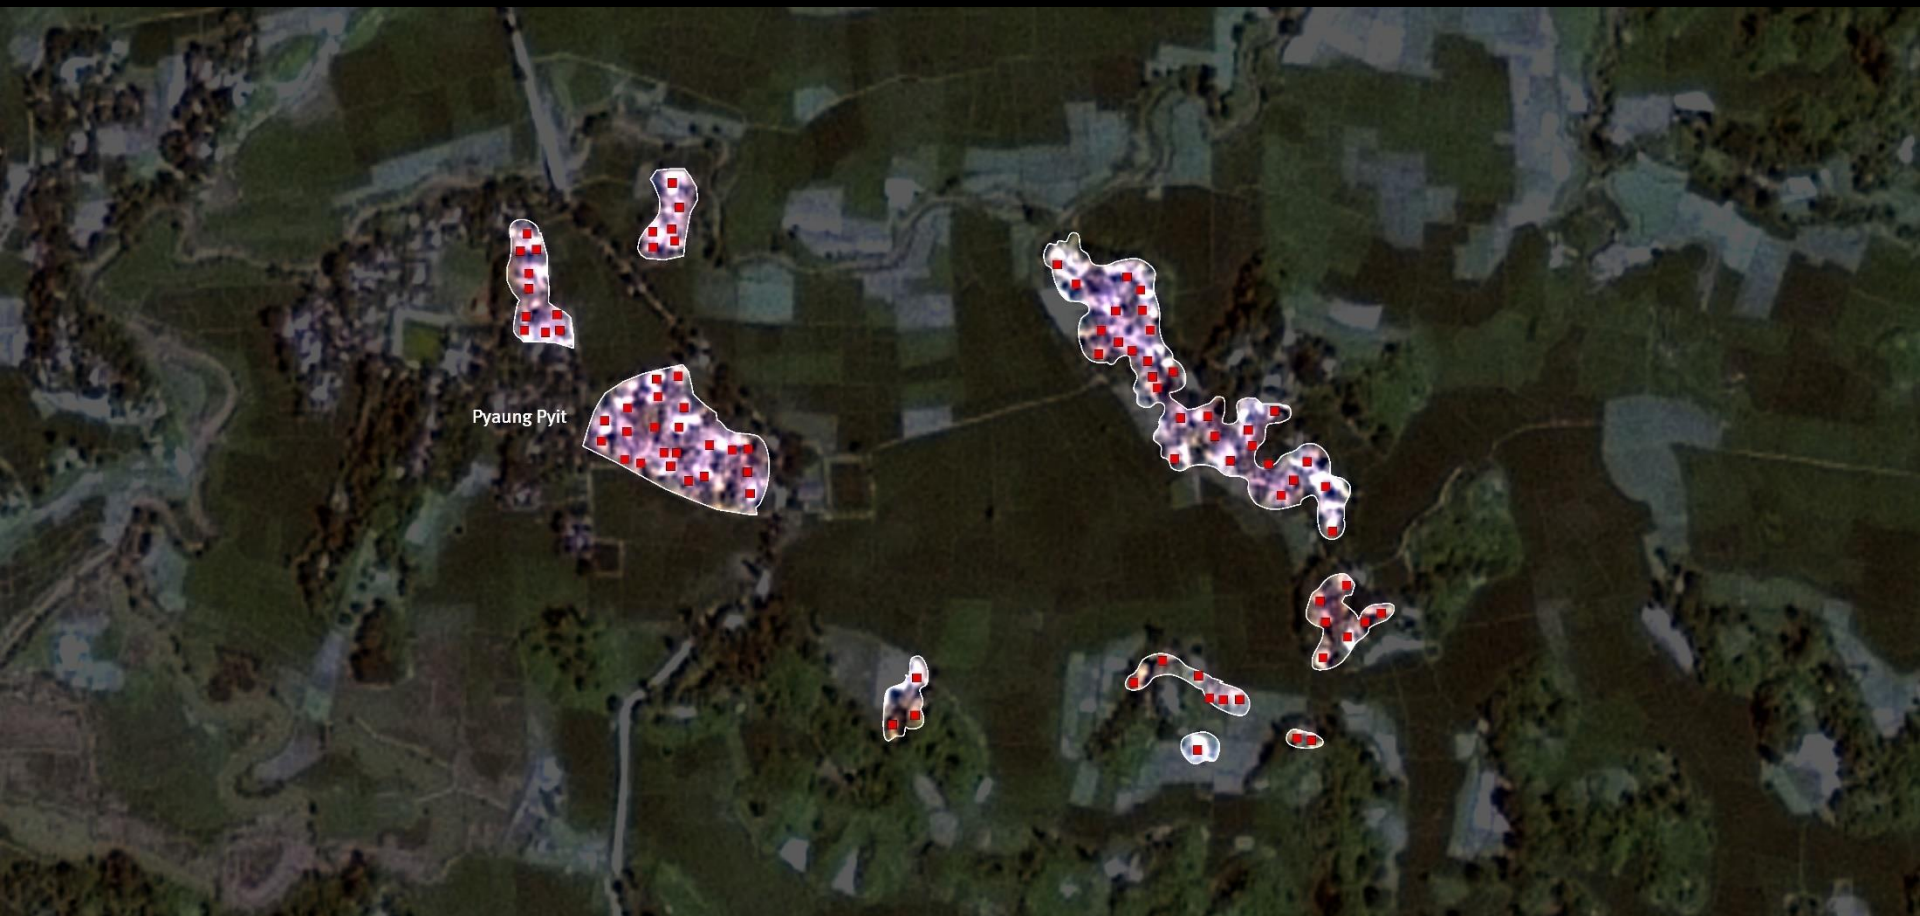
Building destruction in the village of Pyaung Pyit (Ngar Sar Kyu), Maungdaw District

A total of 85 buildings were destroyed in the village of Pyaung Pyit (Ngar Sar Kyu) based on satellite imagery recorded on the mornings of 22 October and 10 November 2016. Damages are consistent with arson.

Because of dense tree cover it is possible that a limited number of fire-affected buildings were not detected. The actual number of building destruction in Pyaung Pyit could be higher.

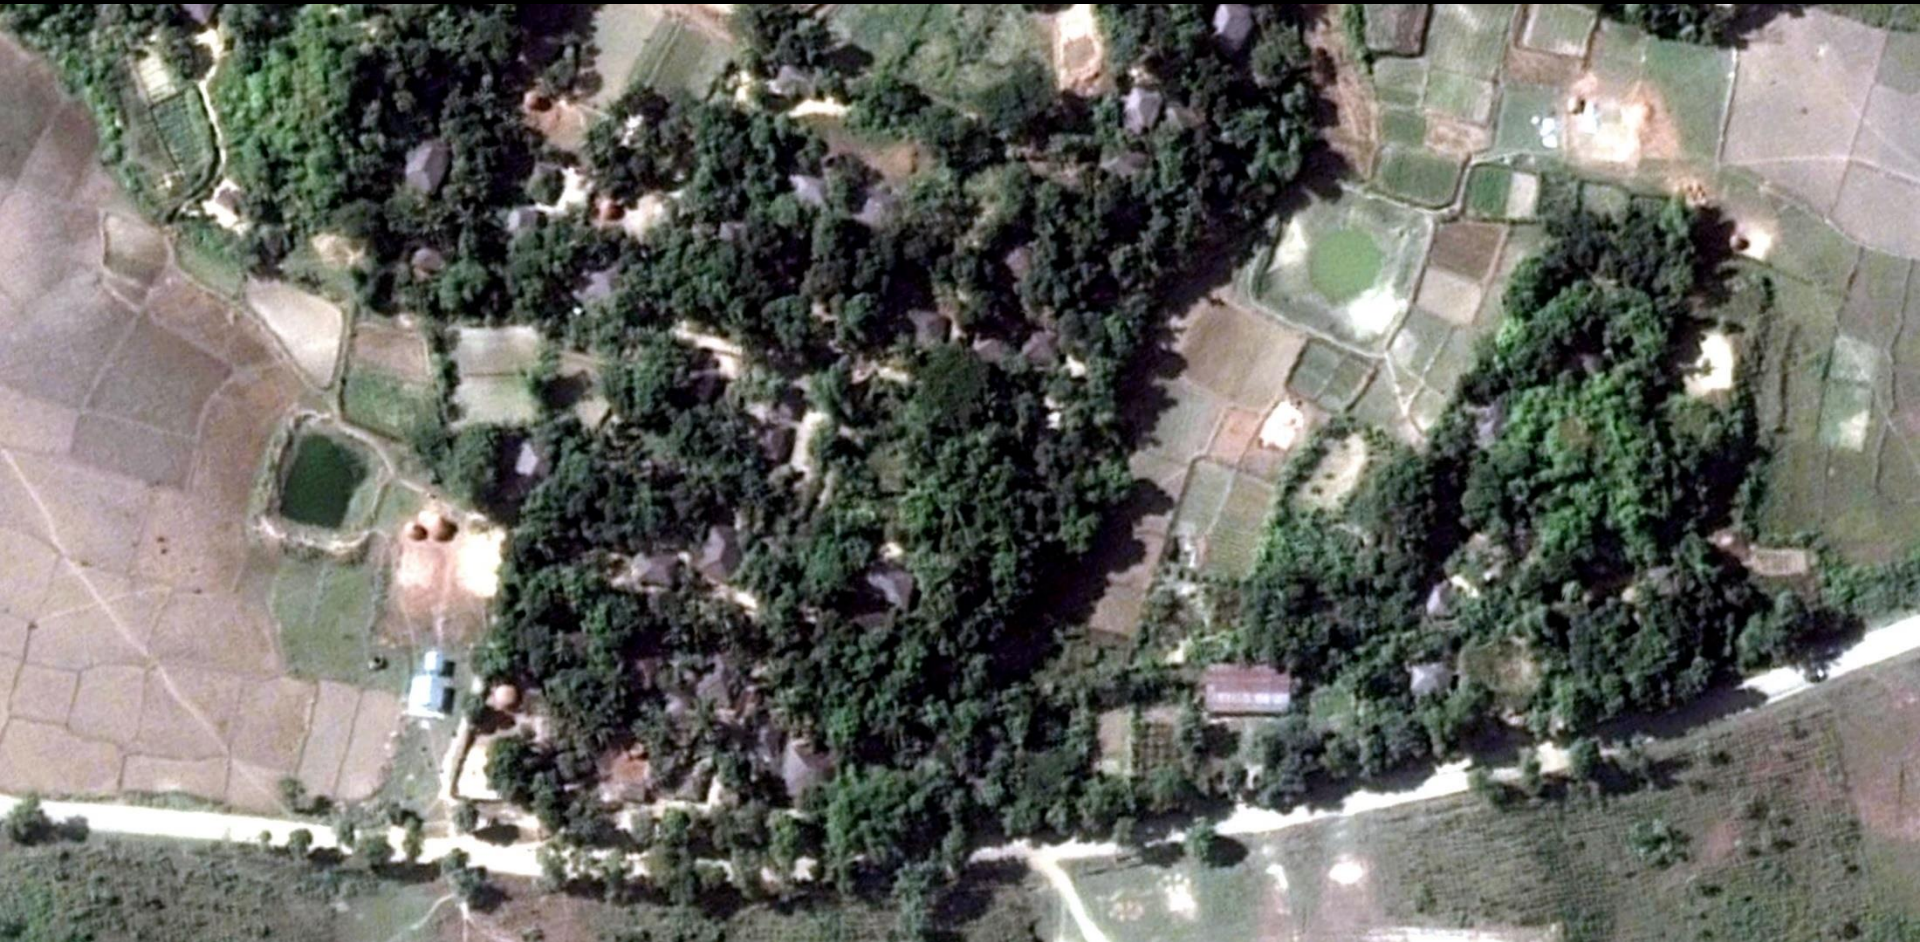
Building destruction in the village of Wa Peik (Kyee Kan Pyin), Maungdaw District Pre-destruction satellite image recorded in 2014

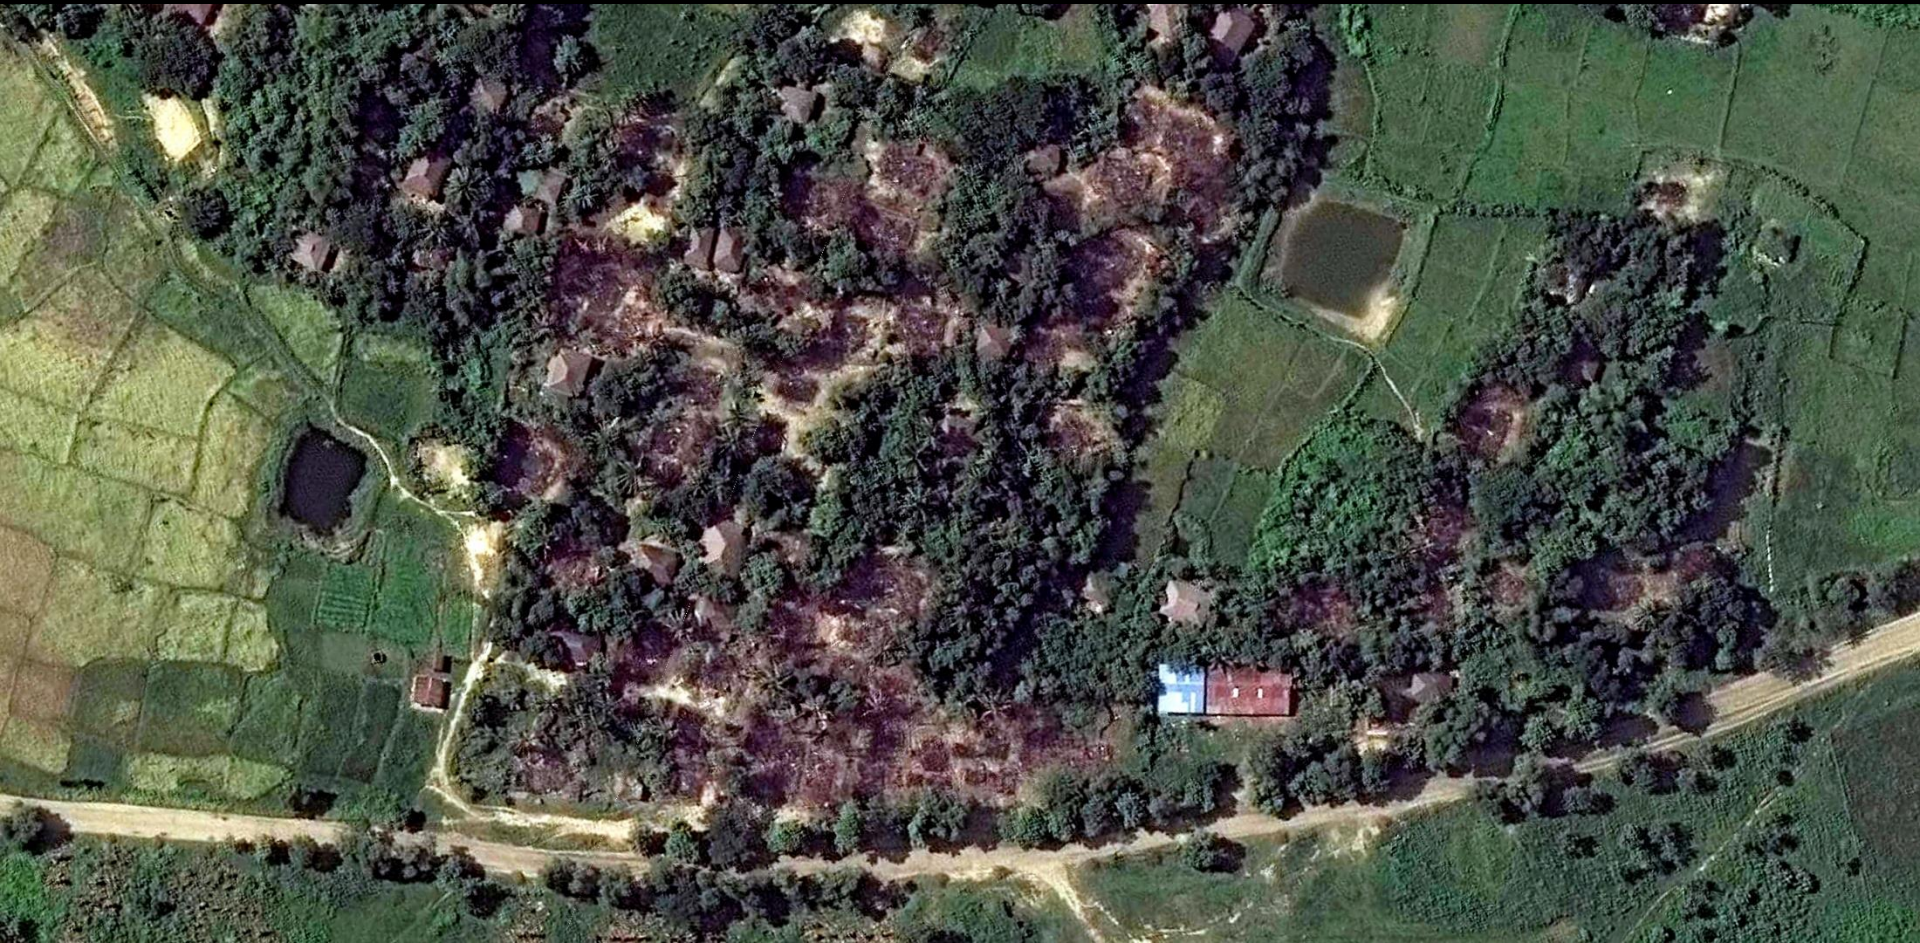
Building destruction in the village of Wa Peik (Kye Kan Pyin), Maungdaw District Post-destruction satellite image recorded on 10 November 2016

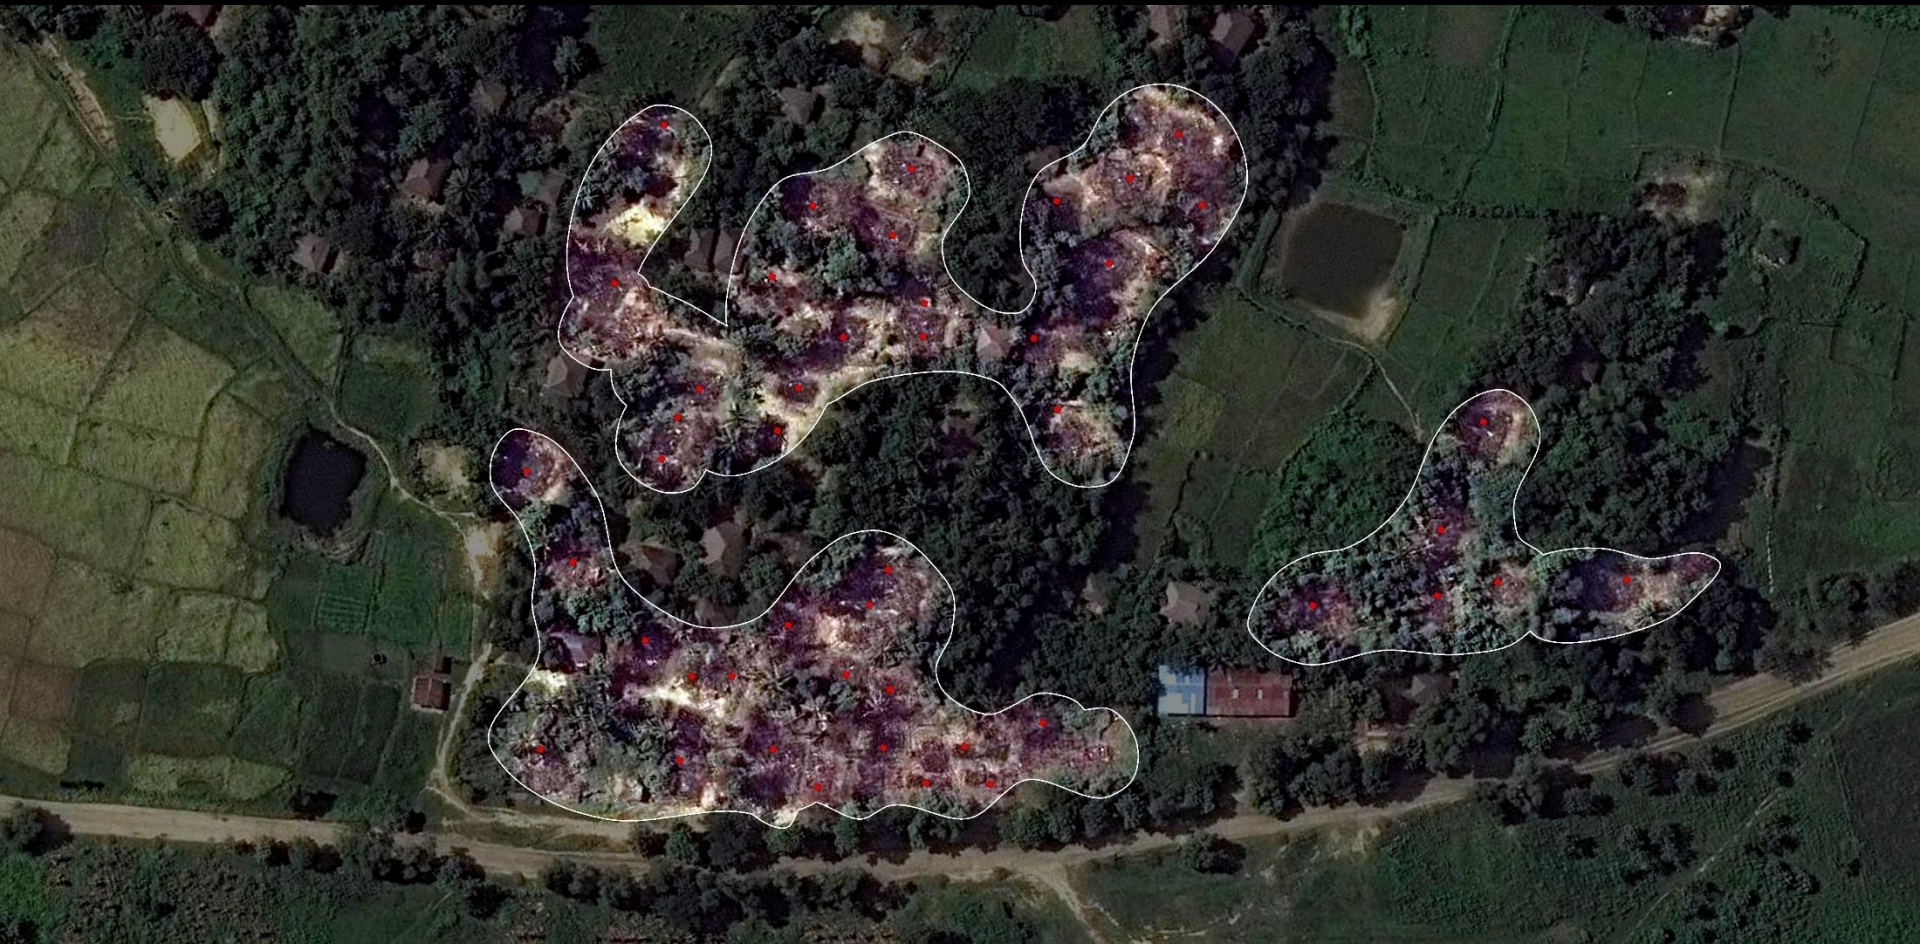
Building destruction in the village of Wa Peik (Kye Kan Pyin), Maungdaw District
Post-destruction satellite image recorded on 10 November 2016 - Destroyed buildings annotated in red

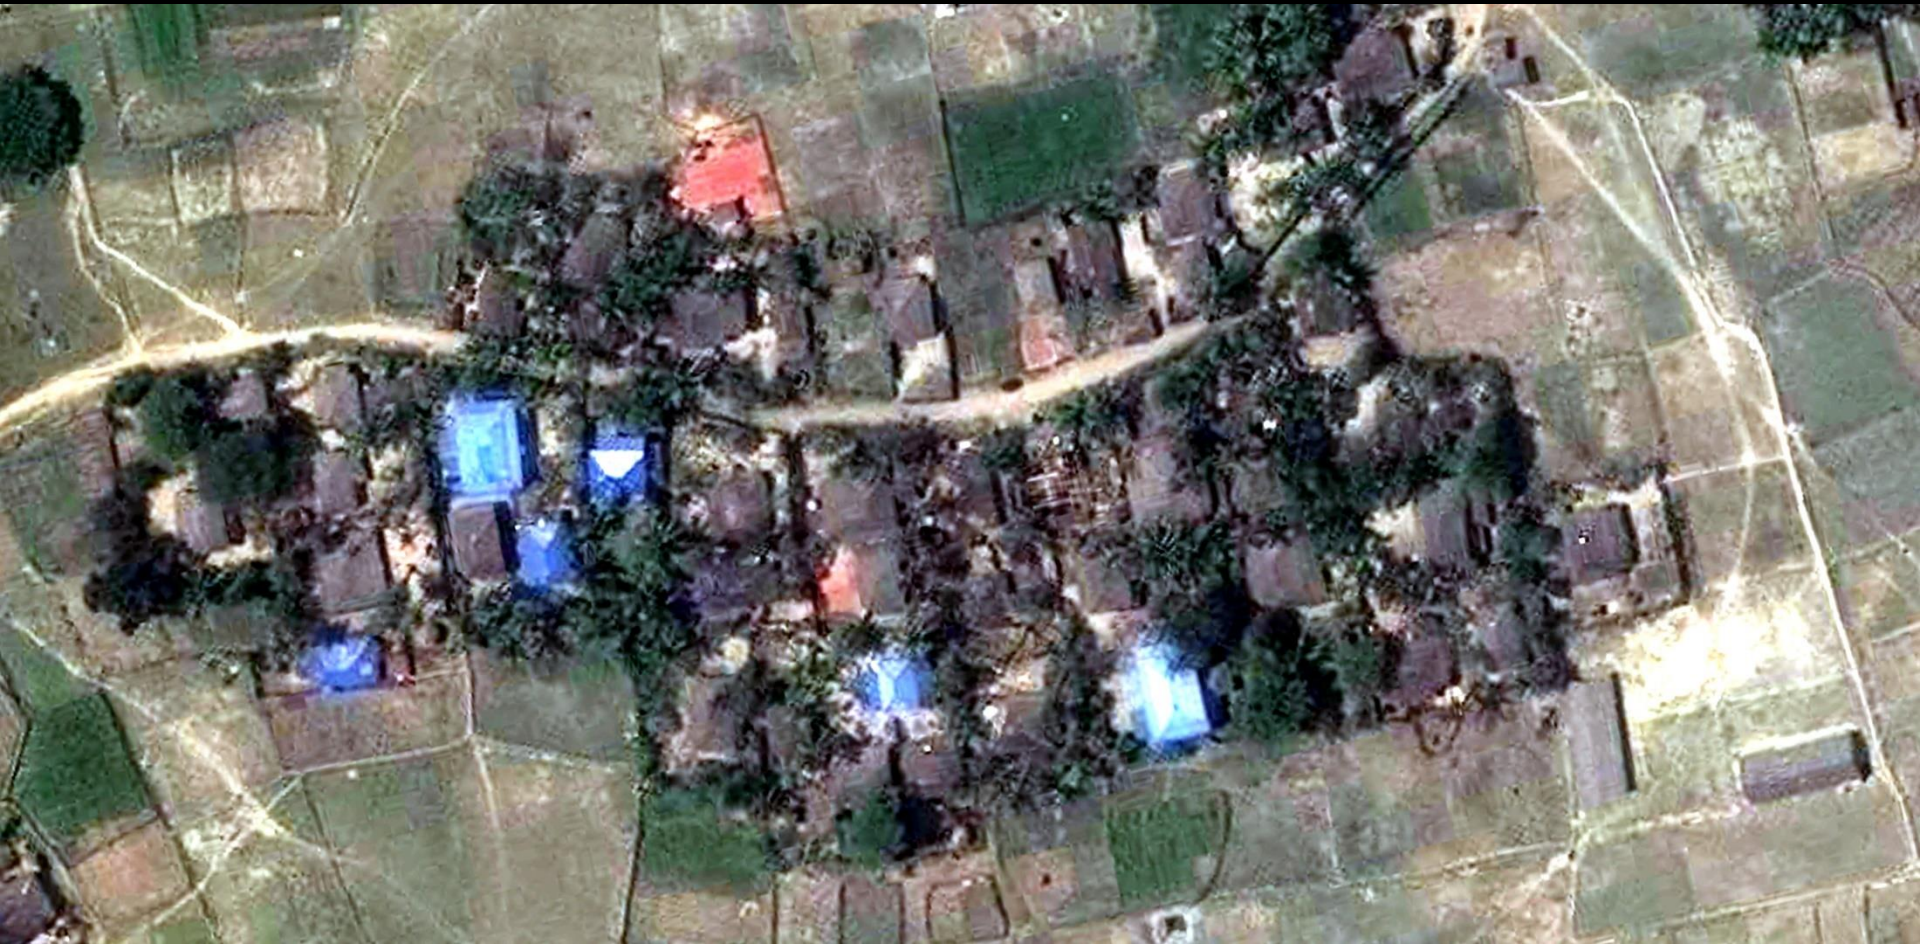
Building destruction in the village of Kyet Yoe Pyin, Maungdaw District
Pre-destruction satellite image recorded on 30 March 2016
