# Updated Damage Assessment of Affected Villages in Maungdaw District

(Assessment based on satellite imagery recorded on 10, 17 and 18 November 2016)

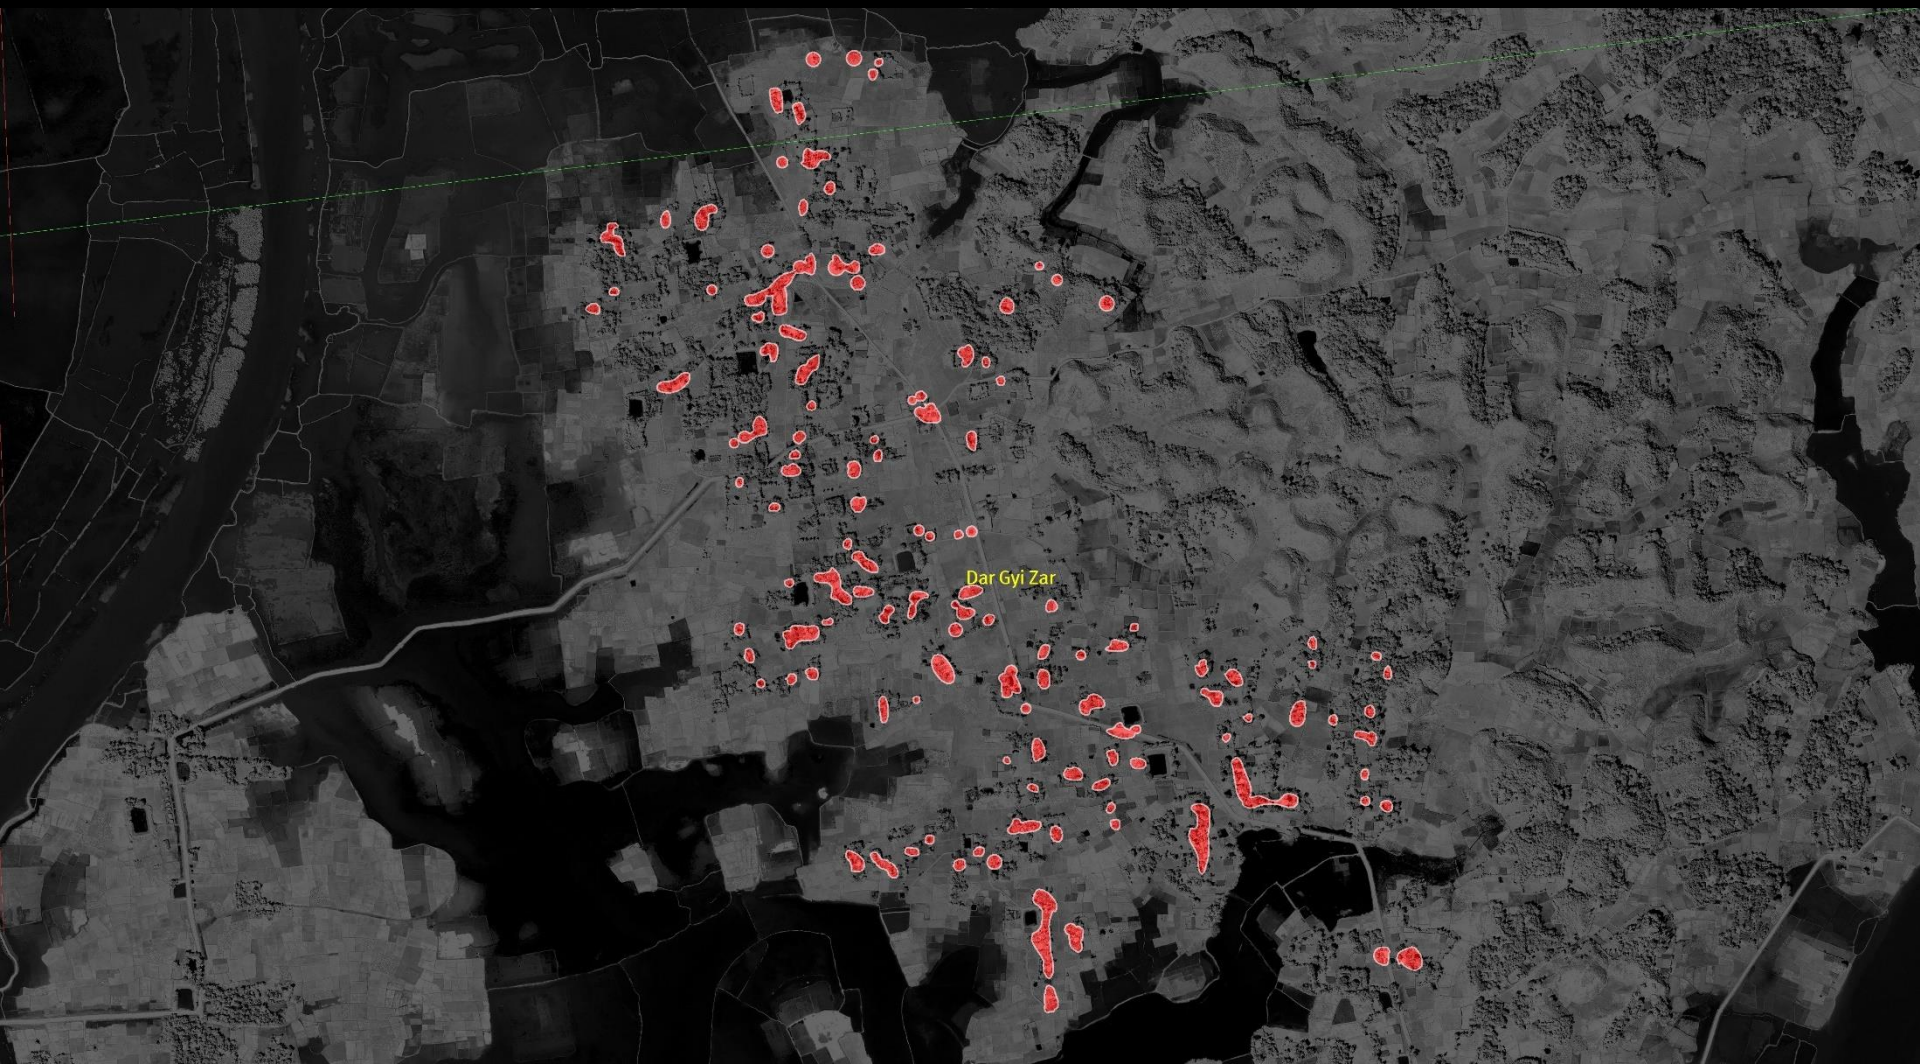
# Overview of Building destruction in the village of Dar Gyi Zar, Maungdaw District

A total of 265 buildings were destroyed in the village of Dar Gyi Zar (MMR012009042) based on a change detection analysis of five very high resolution satellite images recorded 10, 17 and 18 November 2016. Active fires were detected in the village on 13 November by an environmental satellite sensor. The discovery of active fires, extensive burn scars, and destroyed buildings and vegetation in this village is consistent with an arson attack occurring between 10 and 17 November 2016.

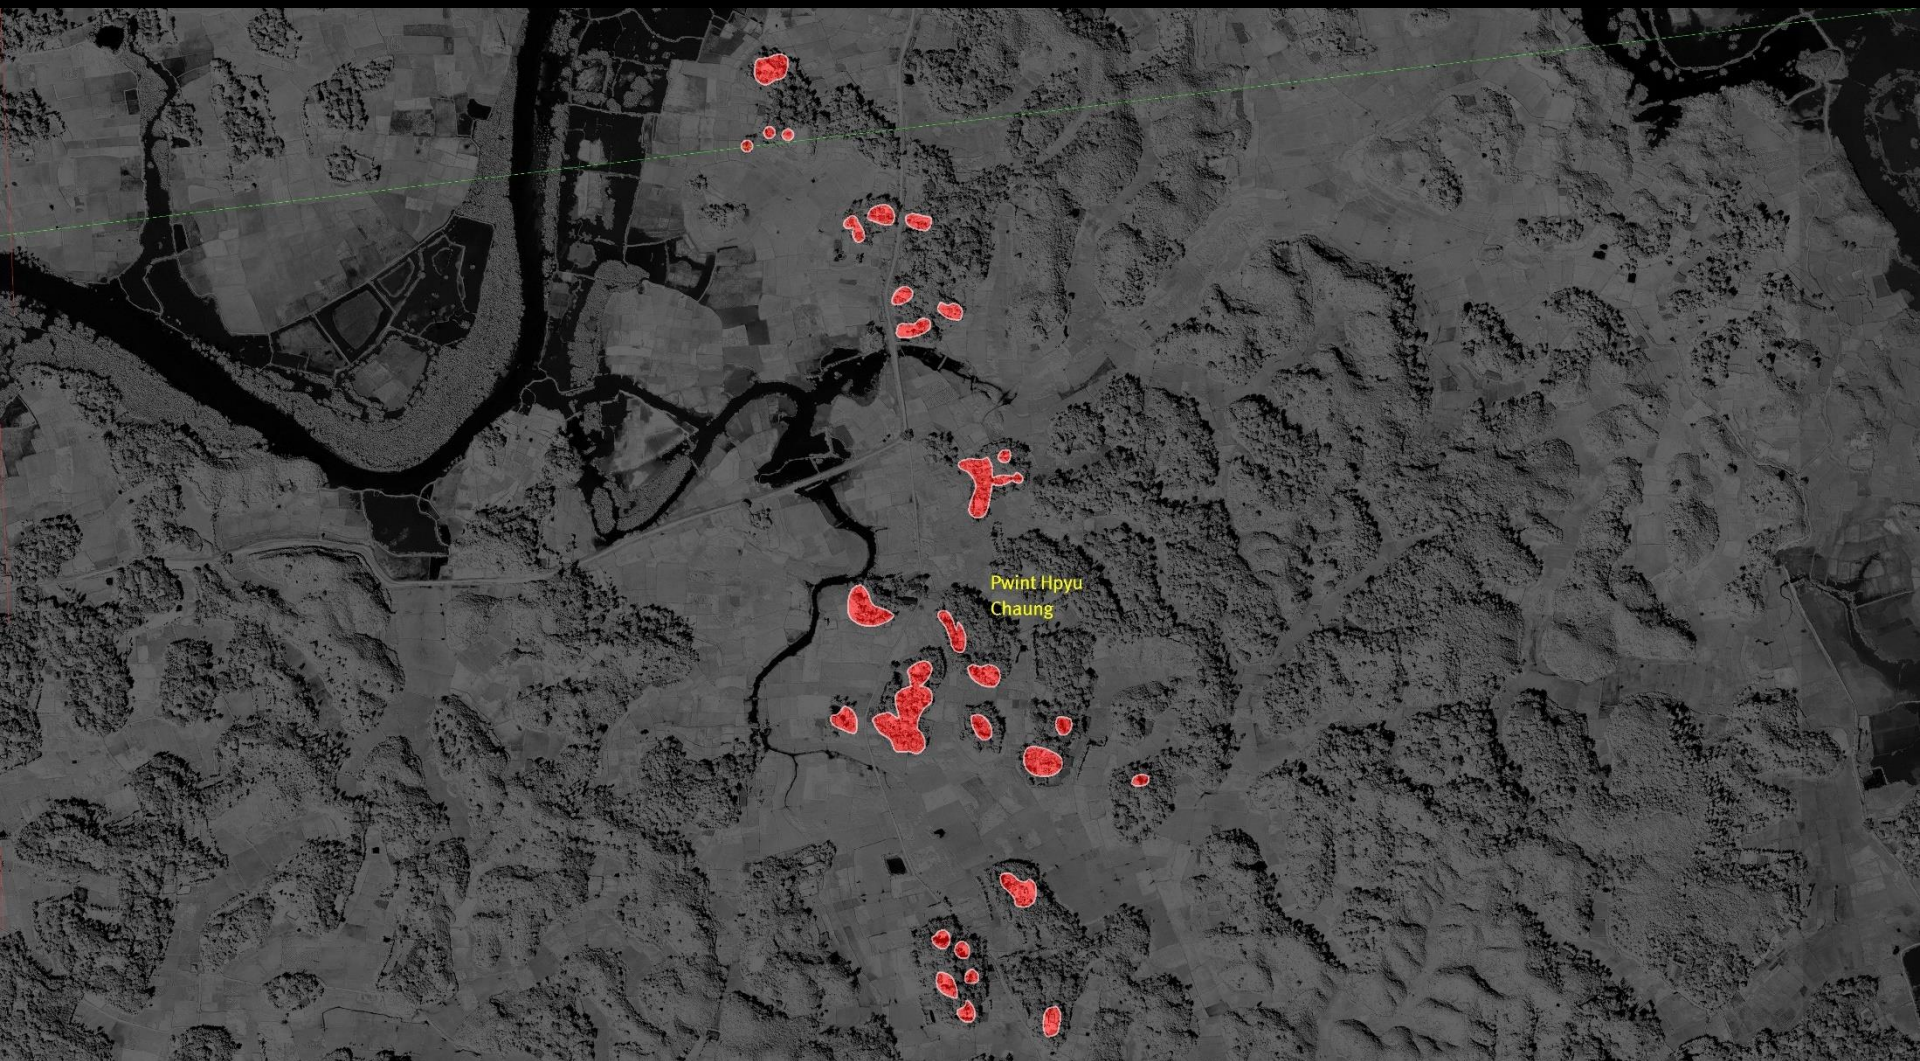
# Overview of Building destruction in the village of Pwint Hpyu Chaung, Maungdaw District

A total of 65 buildings were destroyed in the village of Pwint Hpyu Chaung (MMR012009039) based on a change detection analysis of five very high resolution satellite images recorded 10, 17 and 18 November 2016. Active fires were detected in the village on 12 November by an environmental satellite sensor. The discovery of active fires, burn scars, and destroyed buildings and vegetation in this village is consistent with an arson attack occurring between 10 and 17 November 2016.

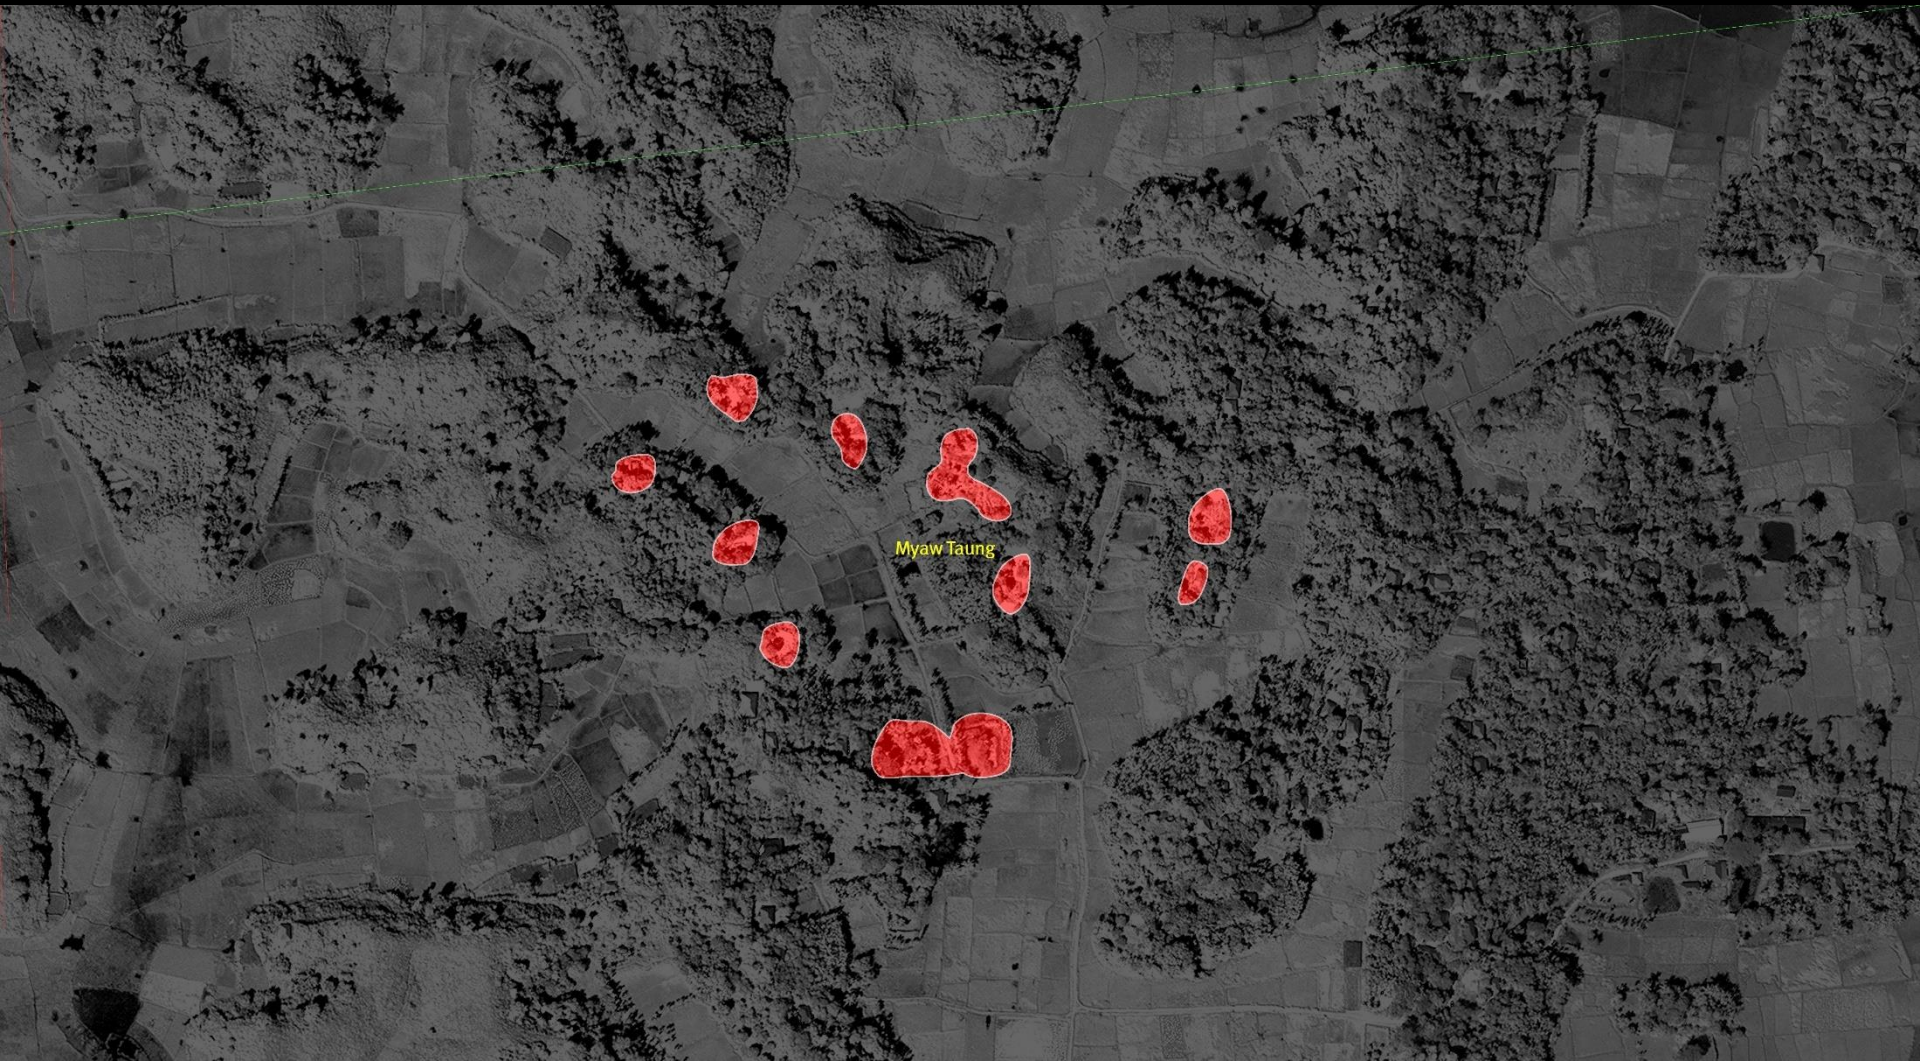
# Overview of Building destruction in the village of Myaw Taung, Maungdaw District

A total of 15 buildings were destroyed in the village of Myaw Taung (MMR012009044) based on a change detection analysis of five very high resolution satellite images recorded 10, 17 and 18 November 2016. The presence of fire burn scars and destroyed buildings and vegetation in this village is consistent with an arson attack occurring between 10 and 17 November 2016.

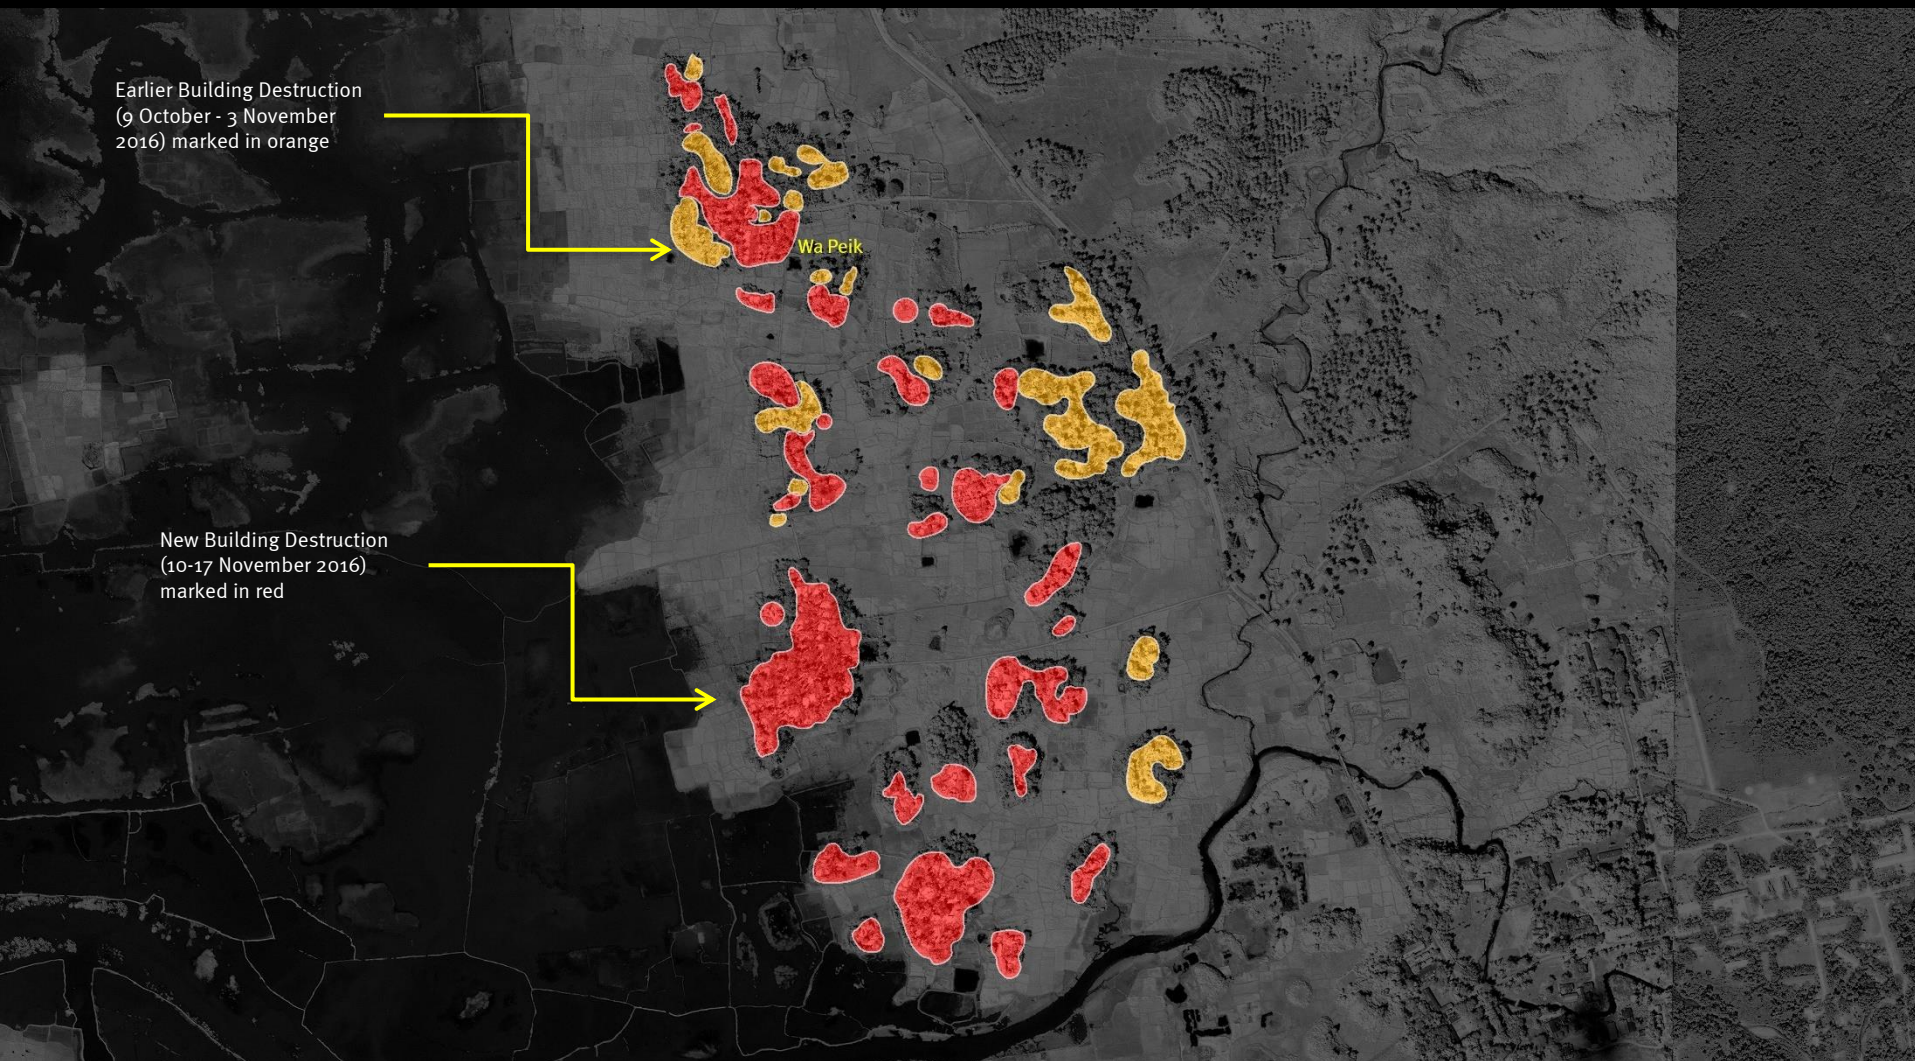
# Overview of new building destruction in the village of Wa Peik, Maungdaw District

A total of 220 buildings were destroyed in the village of Wa Peik (MMRo12009051) based on a change detection analysis of five very high resolution satellite images recorded 10, 17 and 18 November 2016. This destruction is in addition to the 100 buildings destroyed between 9 October and 3 November 2016. The presence of fire burn scars and destroyed buildings and vegetation in this village is consistent with a second arson attack occurring between 10 and 17 November 2016.

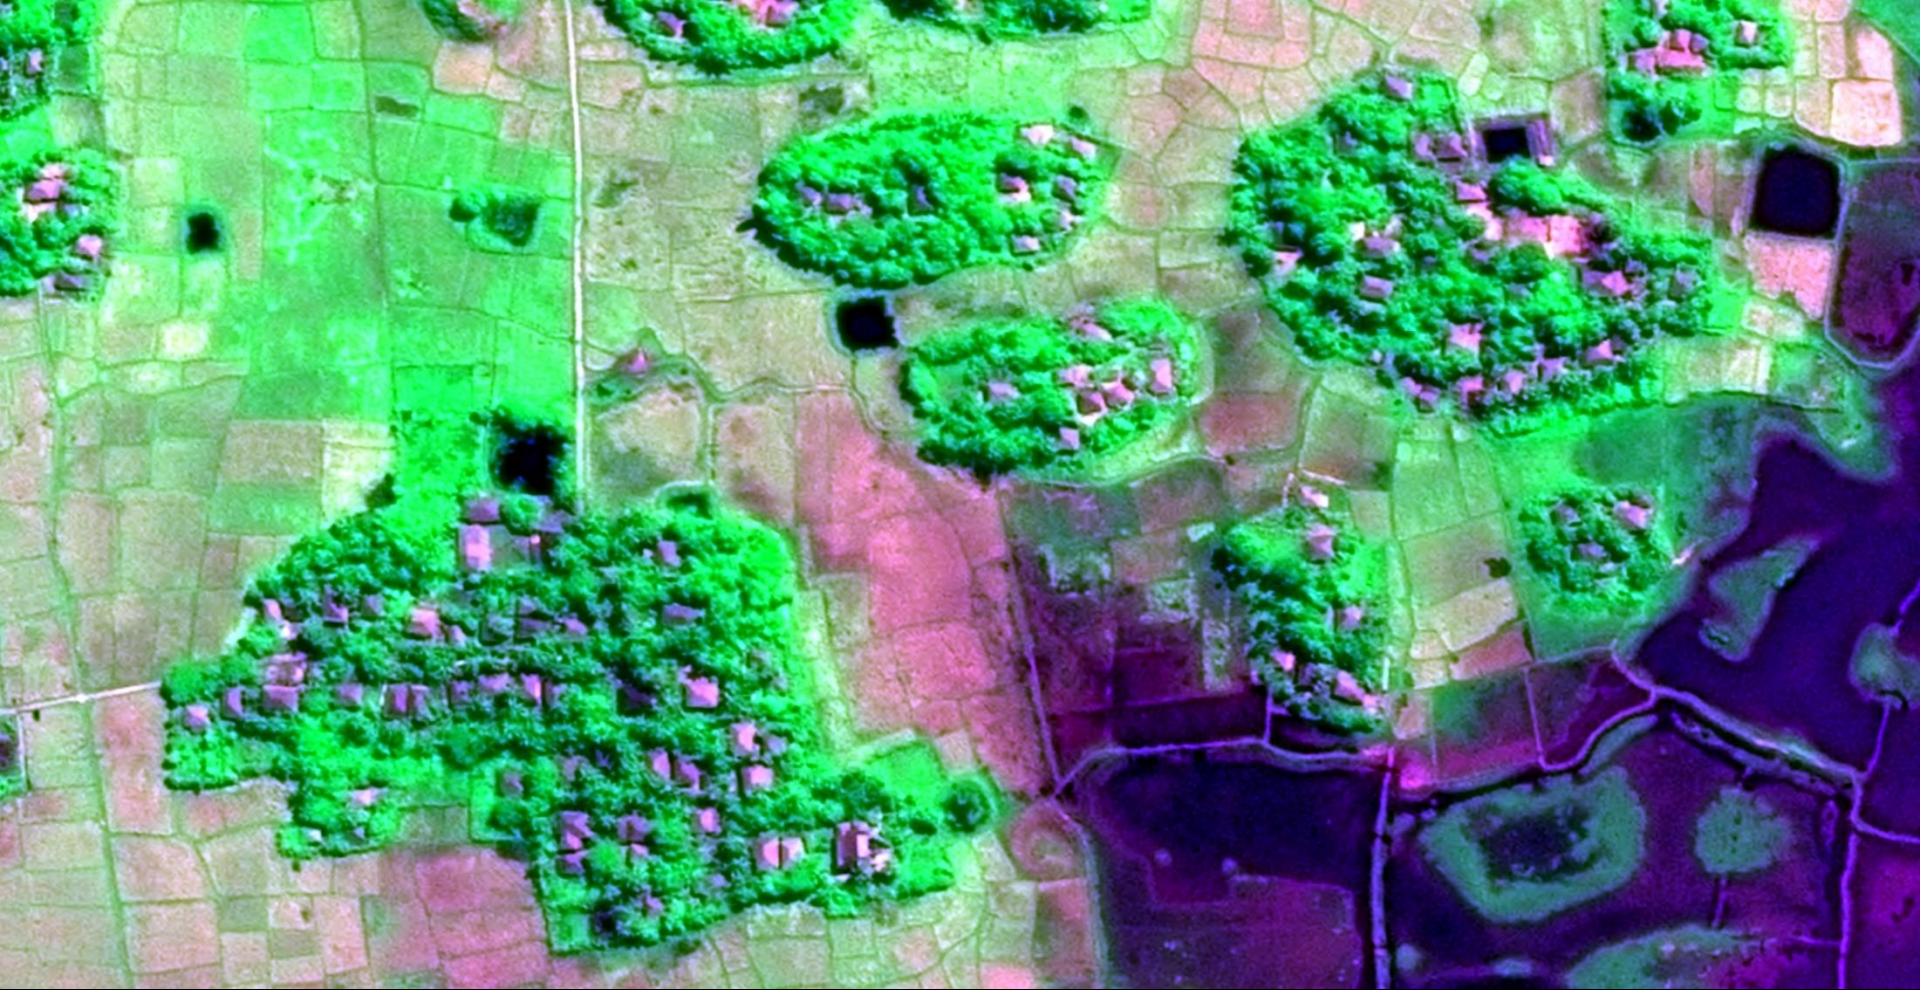
## Continuing building destruction in the village of Wa Peik, Maungdaw District Pre-destruction satellite image recorded on 10 November 2016 – before the second arson attack

Satellite imagery displayed in false-color, near-infrared to highlight areas of extensive fire-related damages and burn scars

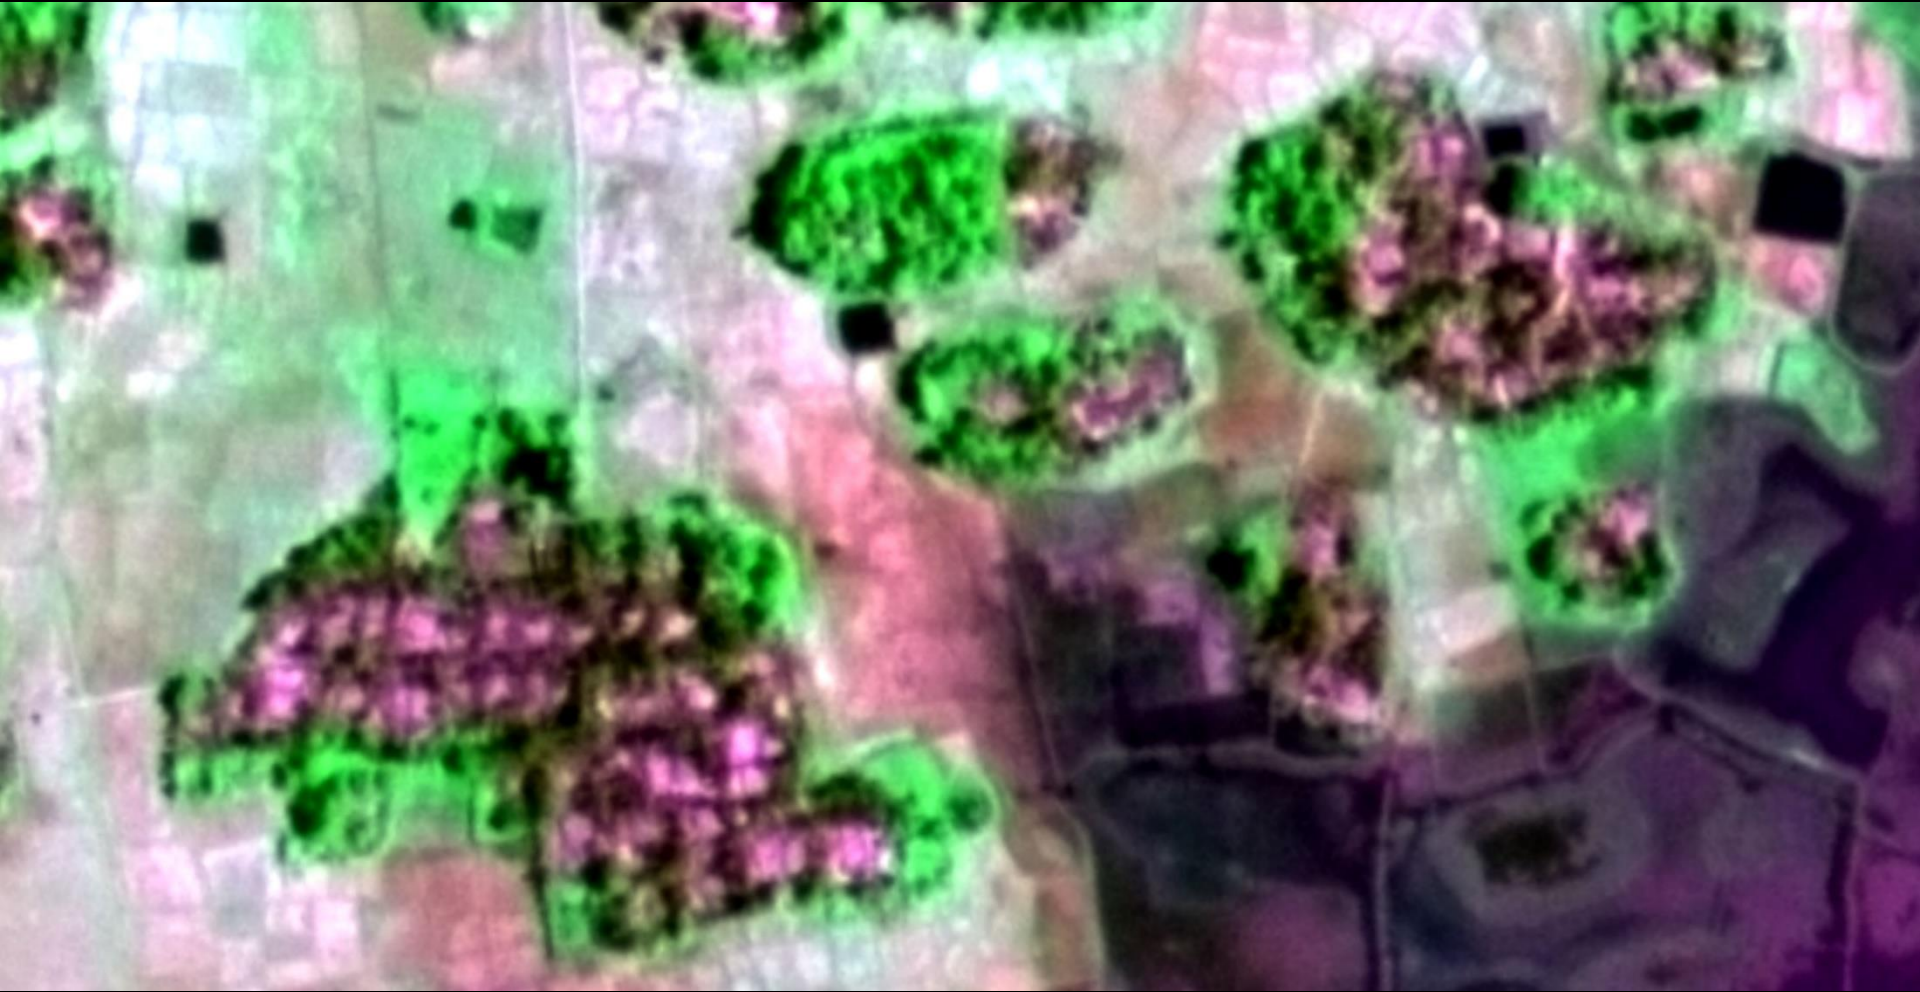
## Continuing building destruction in the village of Wa Peik, Maungdaw District Post-destruction satellite image recorded on 18 November 2016 – after the second arson attack

Satellite imagery displayed in false-color, near-infrared to highlight areas of extensive fire-related damages and burn scars

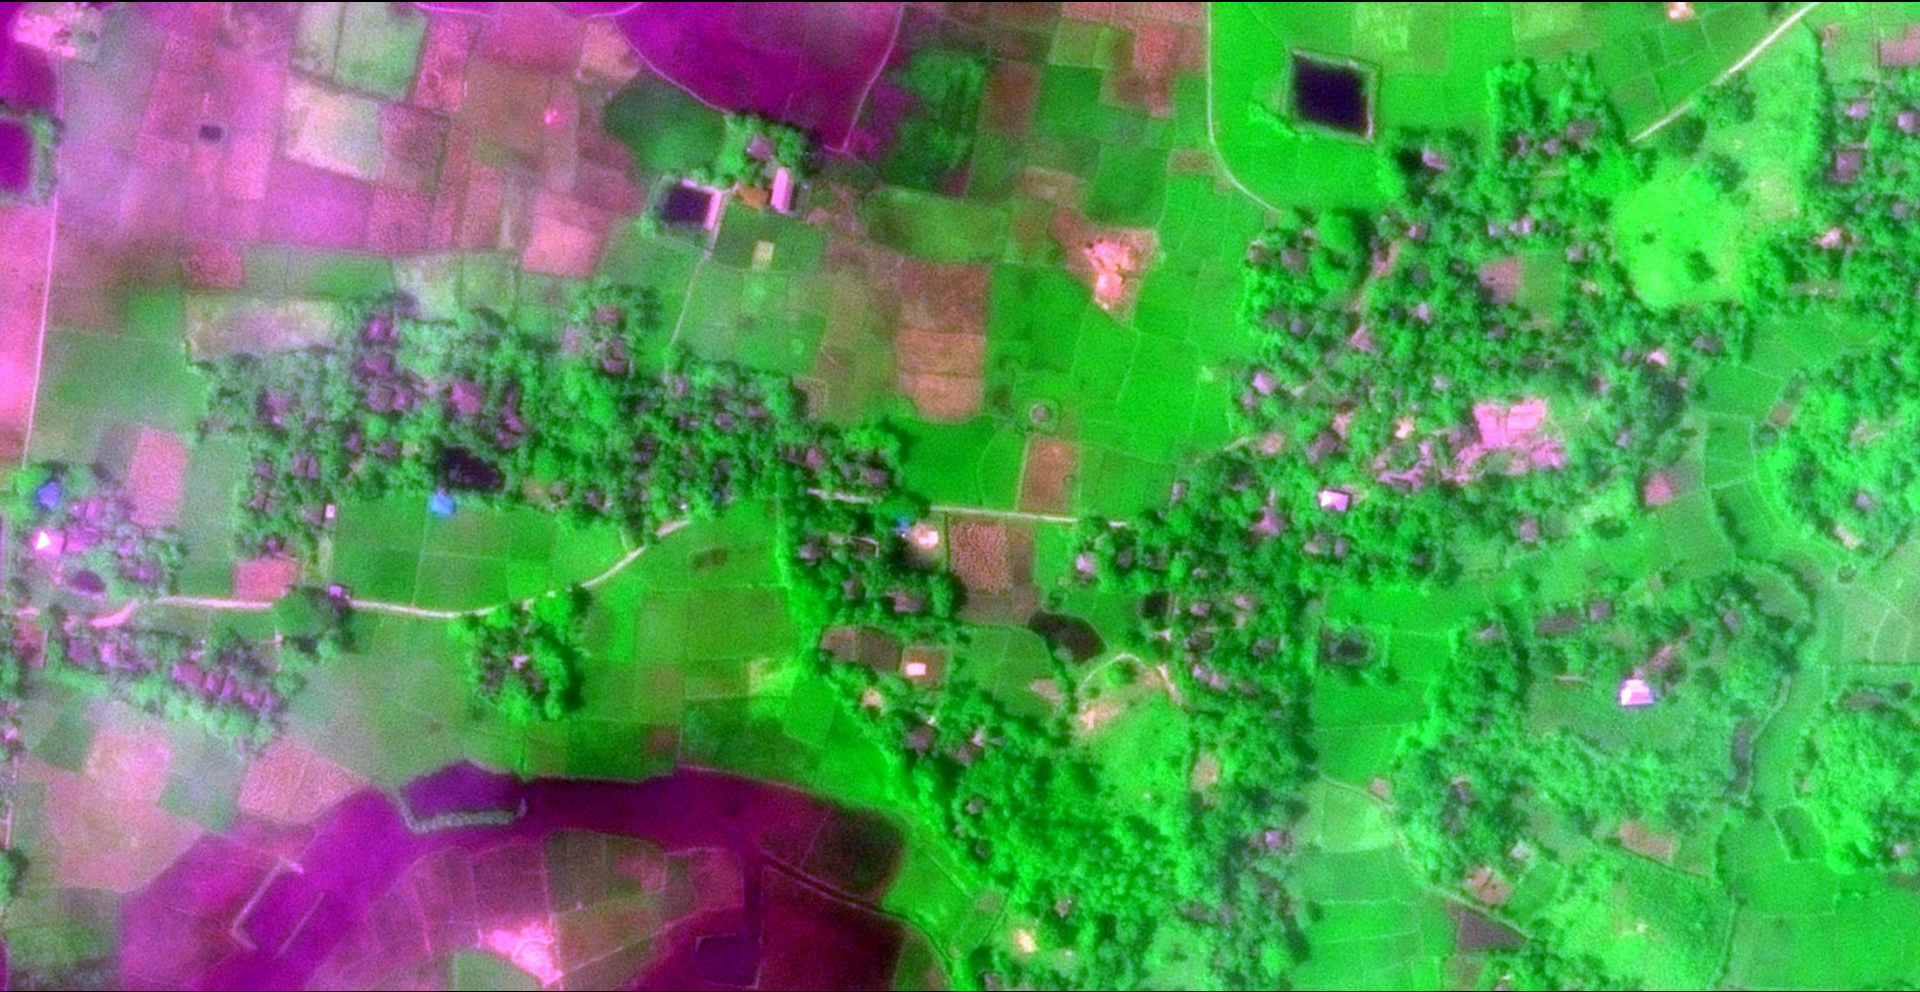
## Building destruction in the village of Yae Khat Chaung Gwa Son (MMRo12009041), Maungdaw District Pre-destruction satellite image recorded on 3 November 2016 – before the arson attack

Satellite imagery displayed in false-color, near-infrared to highlight areas of extensive fire-related damages and burn scars

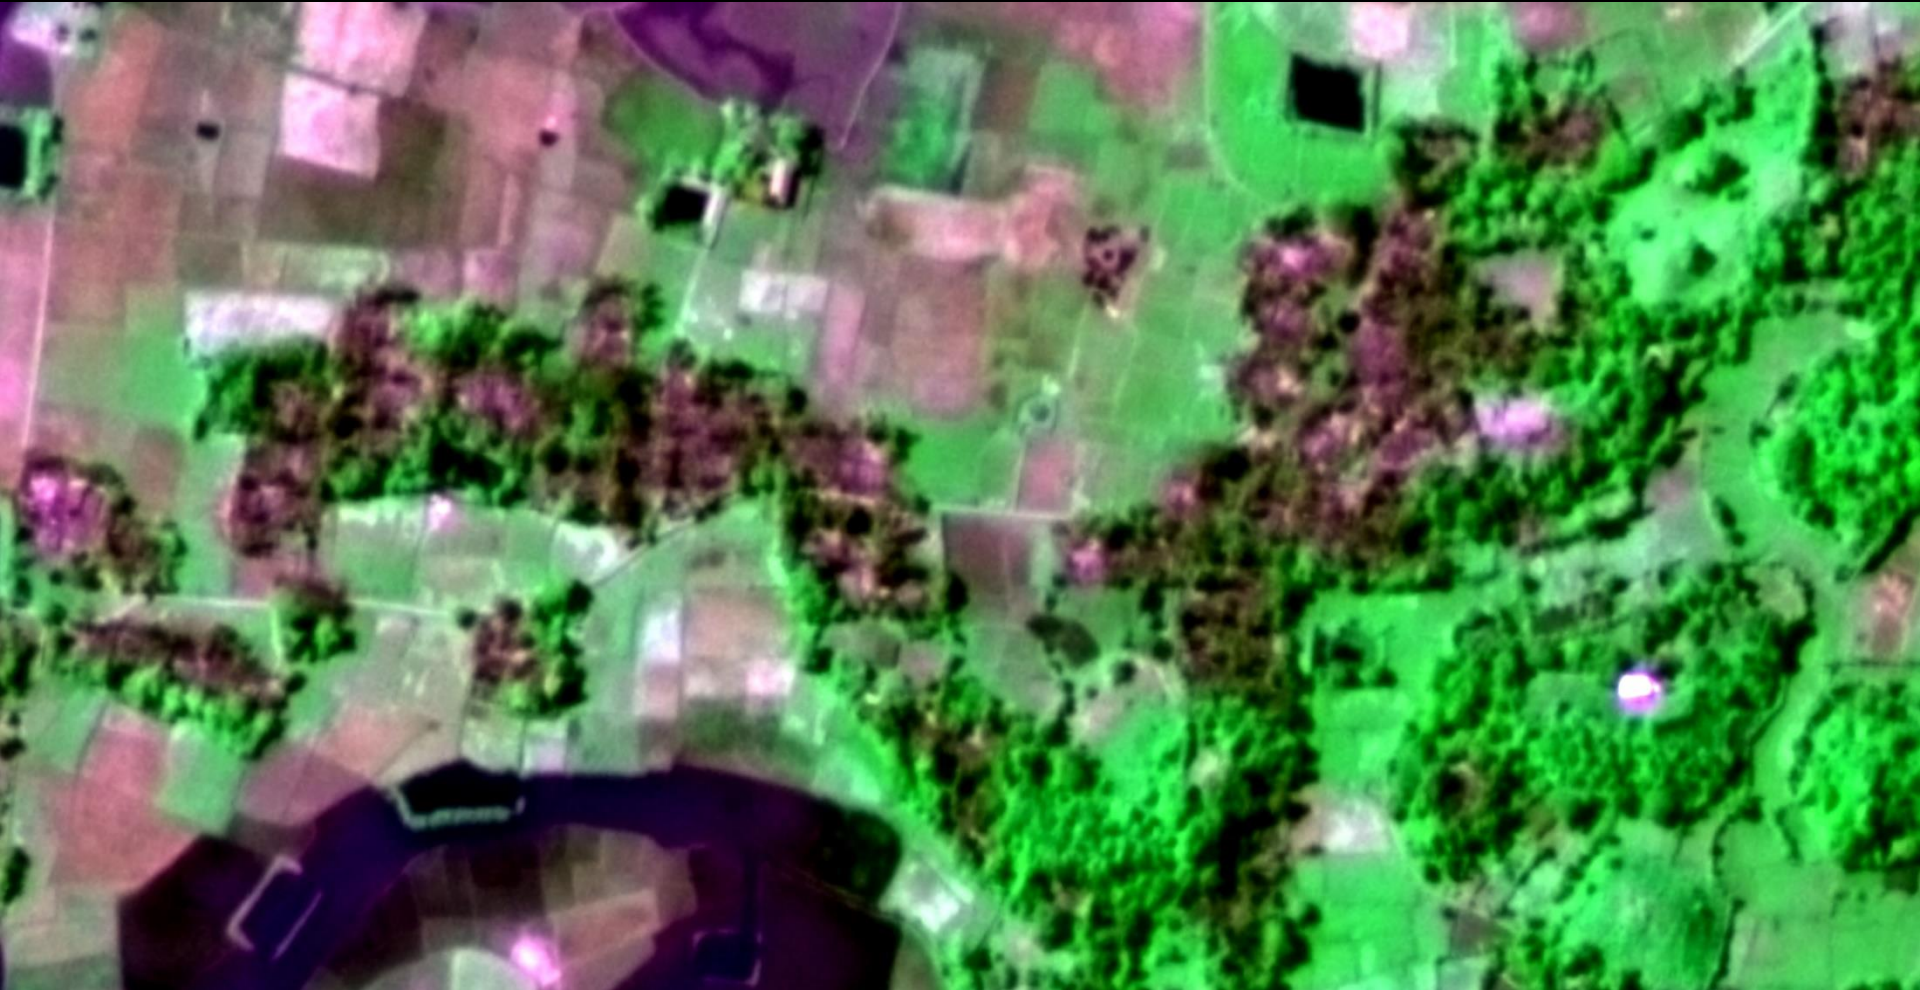
## Building destruction in the village of Yae Khat Chaung Gwa Son (MMRo12009041), Maungdaw District Post-destruction satellite image recorded on 18 November 2016 – after the arson attack

Satellite imagery displayed in false-color, near-infrared to highlight areas of extensive fire-related damages and burn scars
